# **Preliminary Survey of Point Sources of Pollution in La Parguera, Lajas Puerto Rico**

**February 2012**

## Summary:

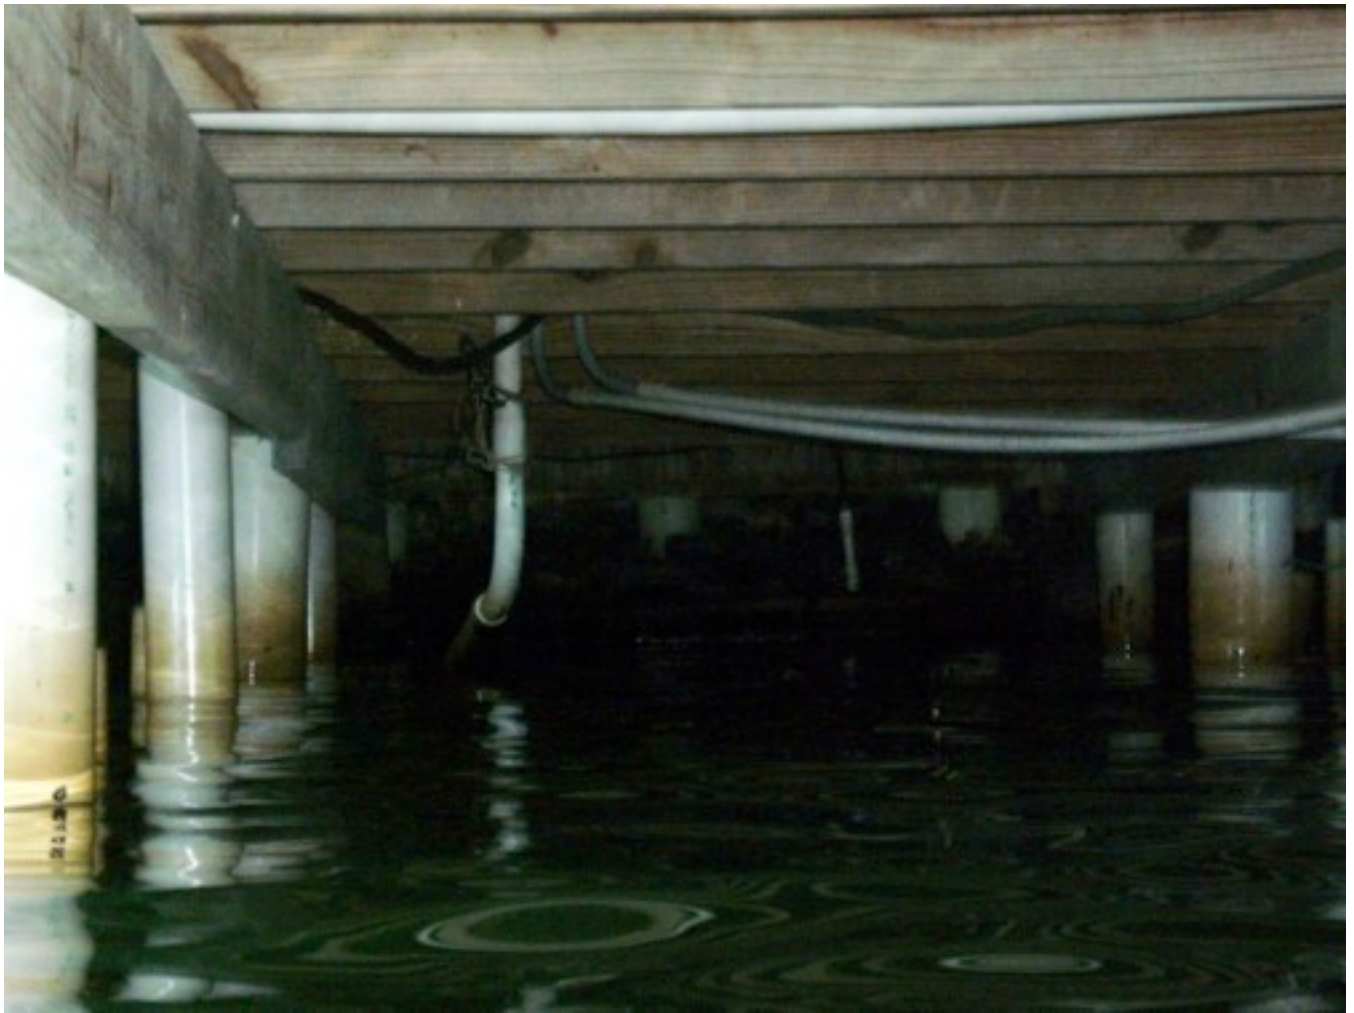
FIGURE 3: PVC pipe discharging directly into the water. This was a common finding among the stilt houses. Undesirable greases and detergents can enter the ecosystem. We observed surface greasy spots in the morning of the 8<sup>th</sup> of February apparently from sinks and or boat cleaning activities.

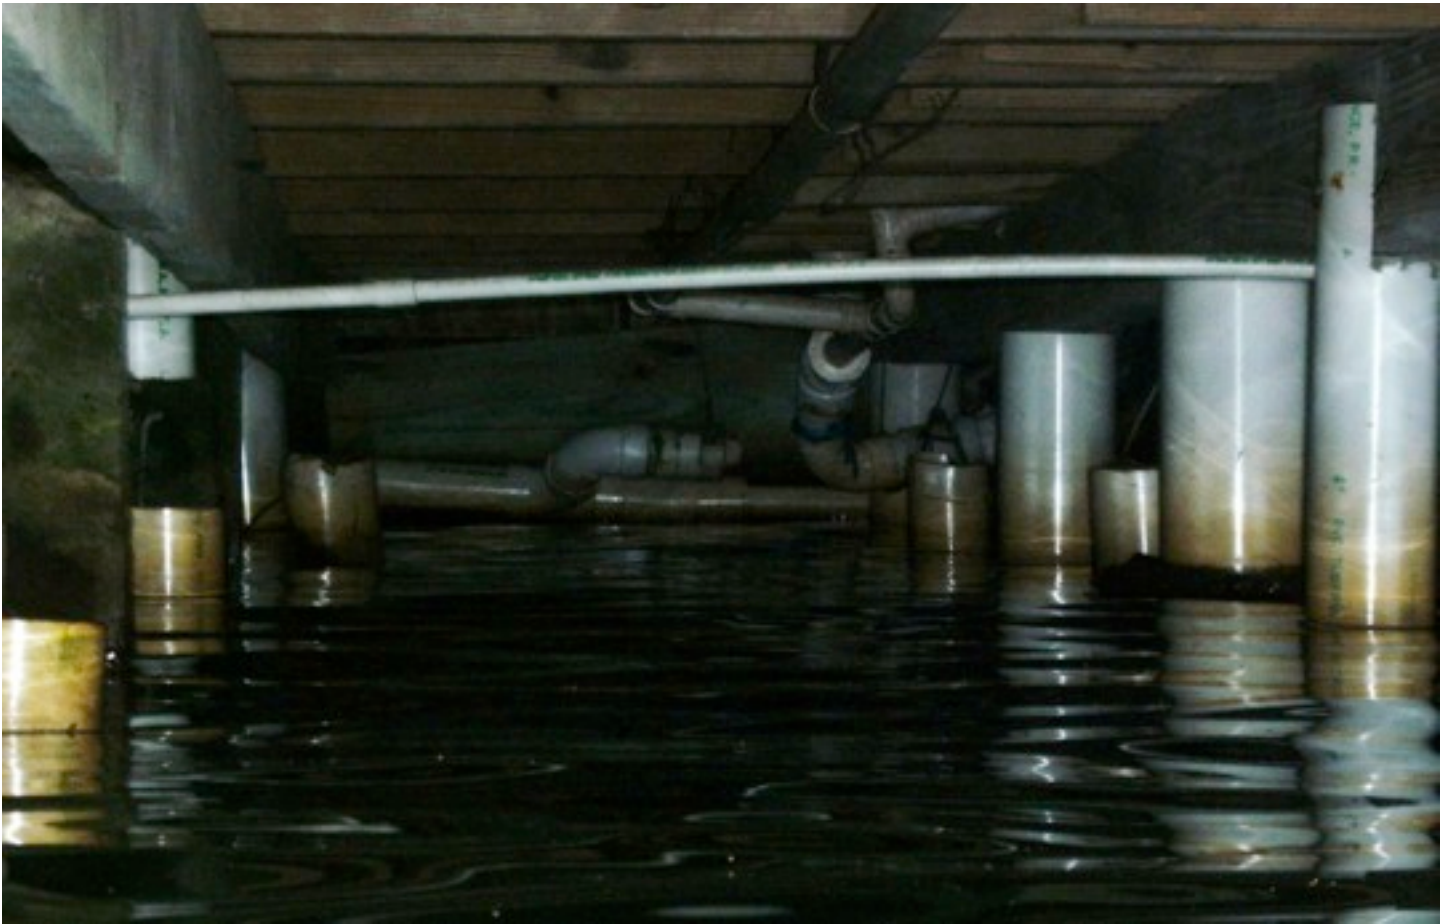
FIGURE 4: Residential PVC sewage profile. A common practice among most of the observed pipes is the use of loose caps. These may serve as a pressure breaker.

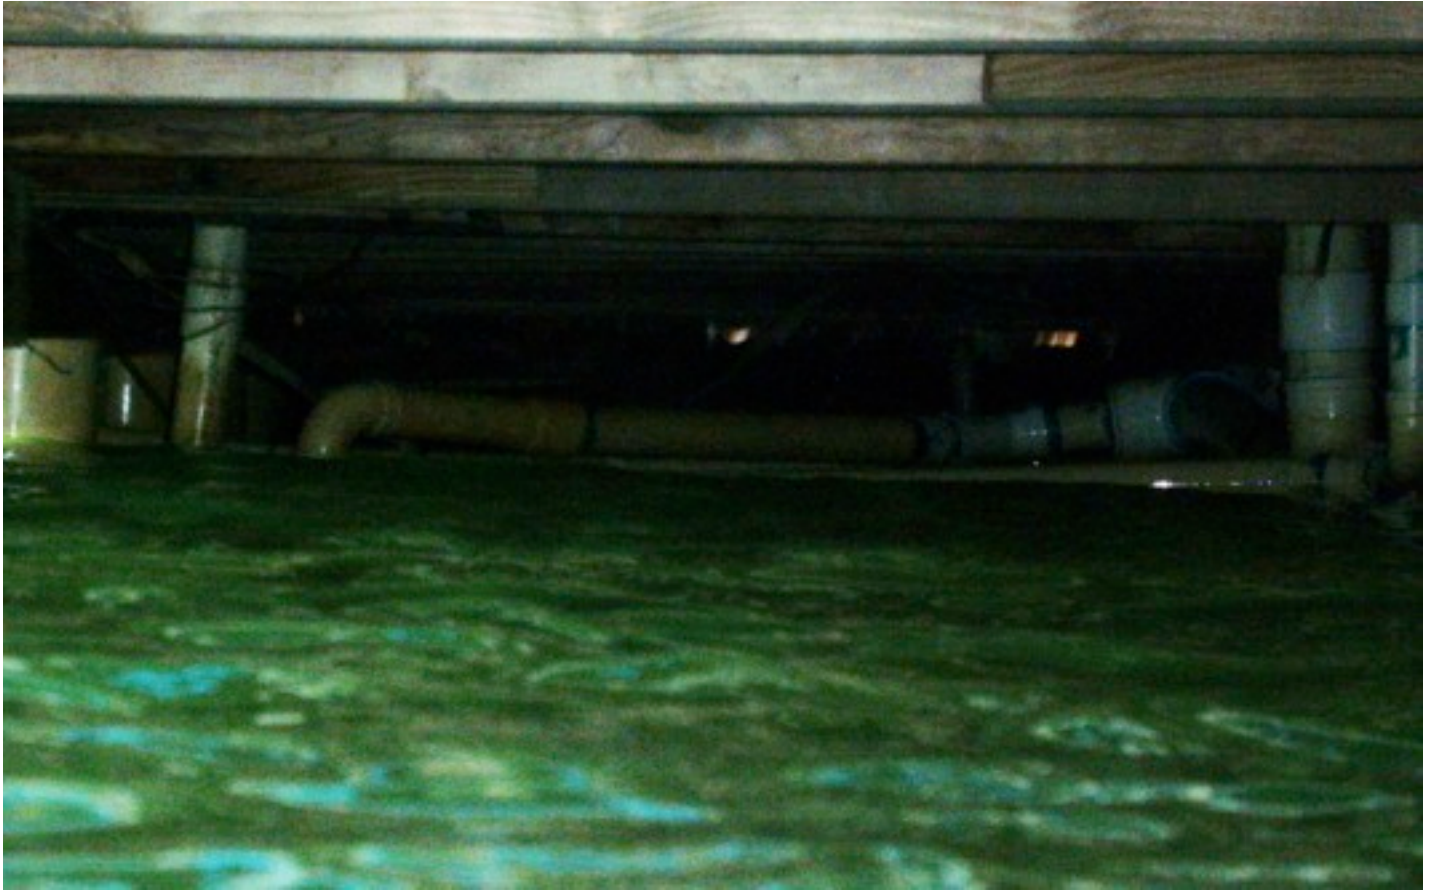
FIGURE 5: Residential PVC sewage profile with direct contact to seawater. We suspect that leakage can be occurring since there is no visible continuity.

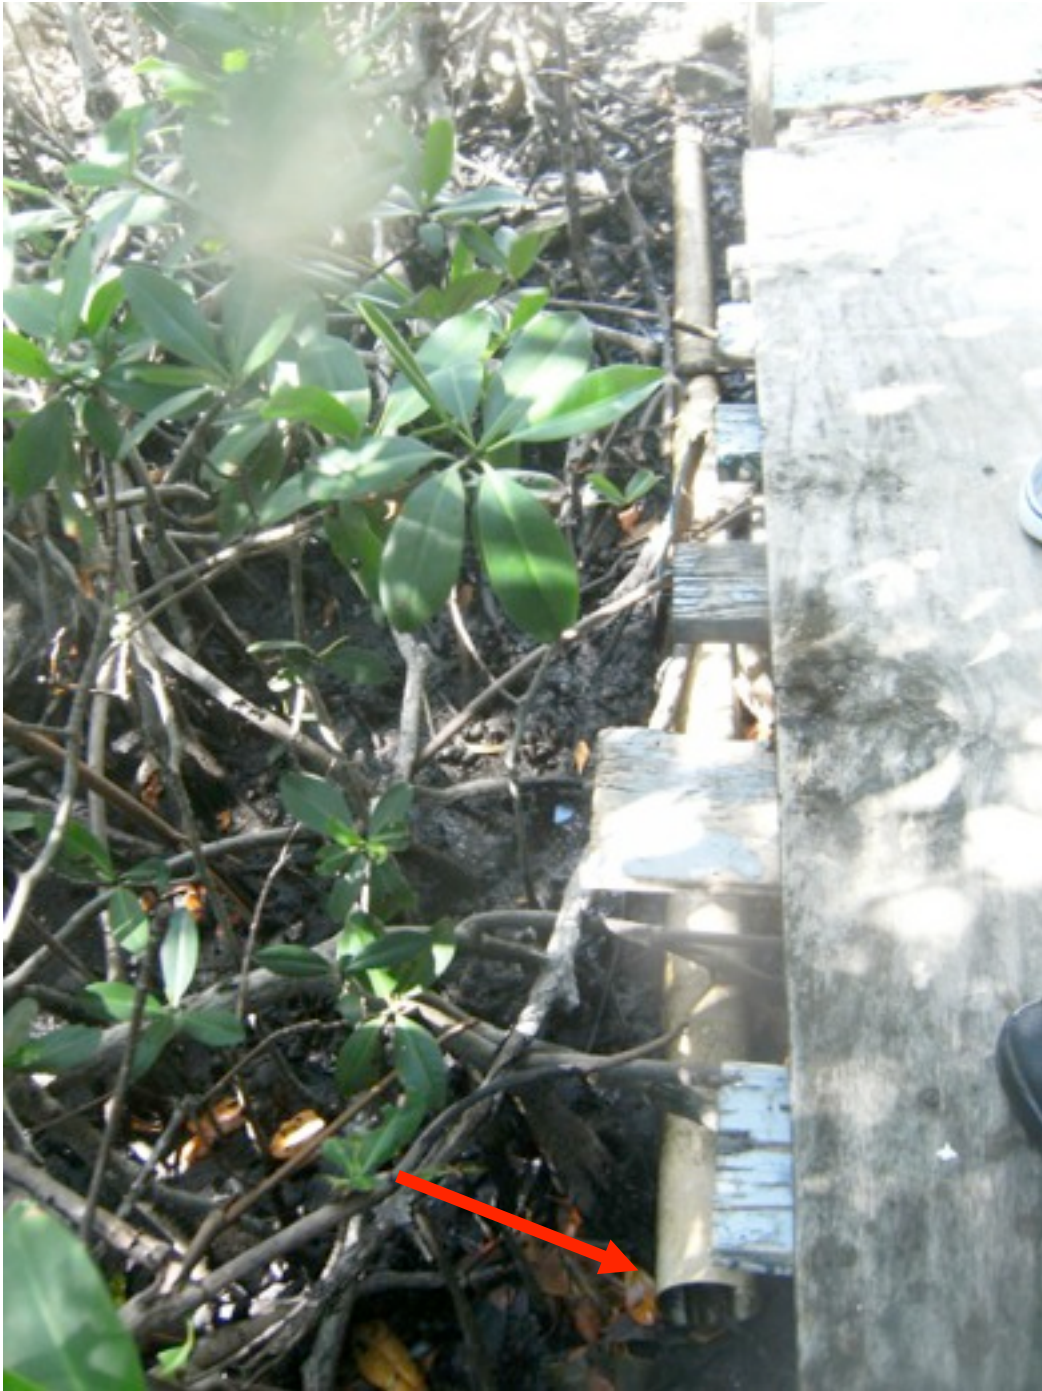
FIGURE 6: Where stilt houses were destroyed, the remaining residential sewage pipes can work as surcharge for the trunk main and as saltwater entrance to the sewer system which may interfere with the processes at the treatment plant.

1. Re-line or re-engineer the main trunk of the sewer system in La Parguera, sealing all connections that are no longer needed and removing defunct pipes; consider a vacuum or other system that will withstand future sea level rise which will further exacerbate inflow and infiltration (I and I) conditions leading to additional coastal pollution.

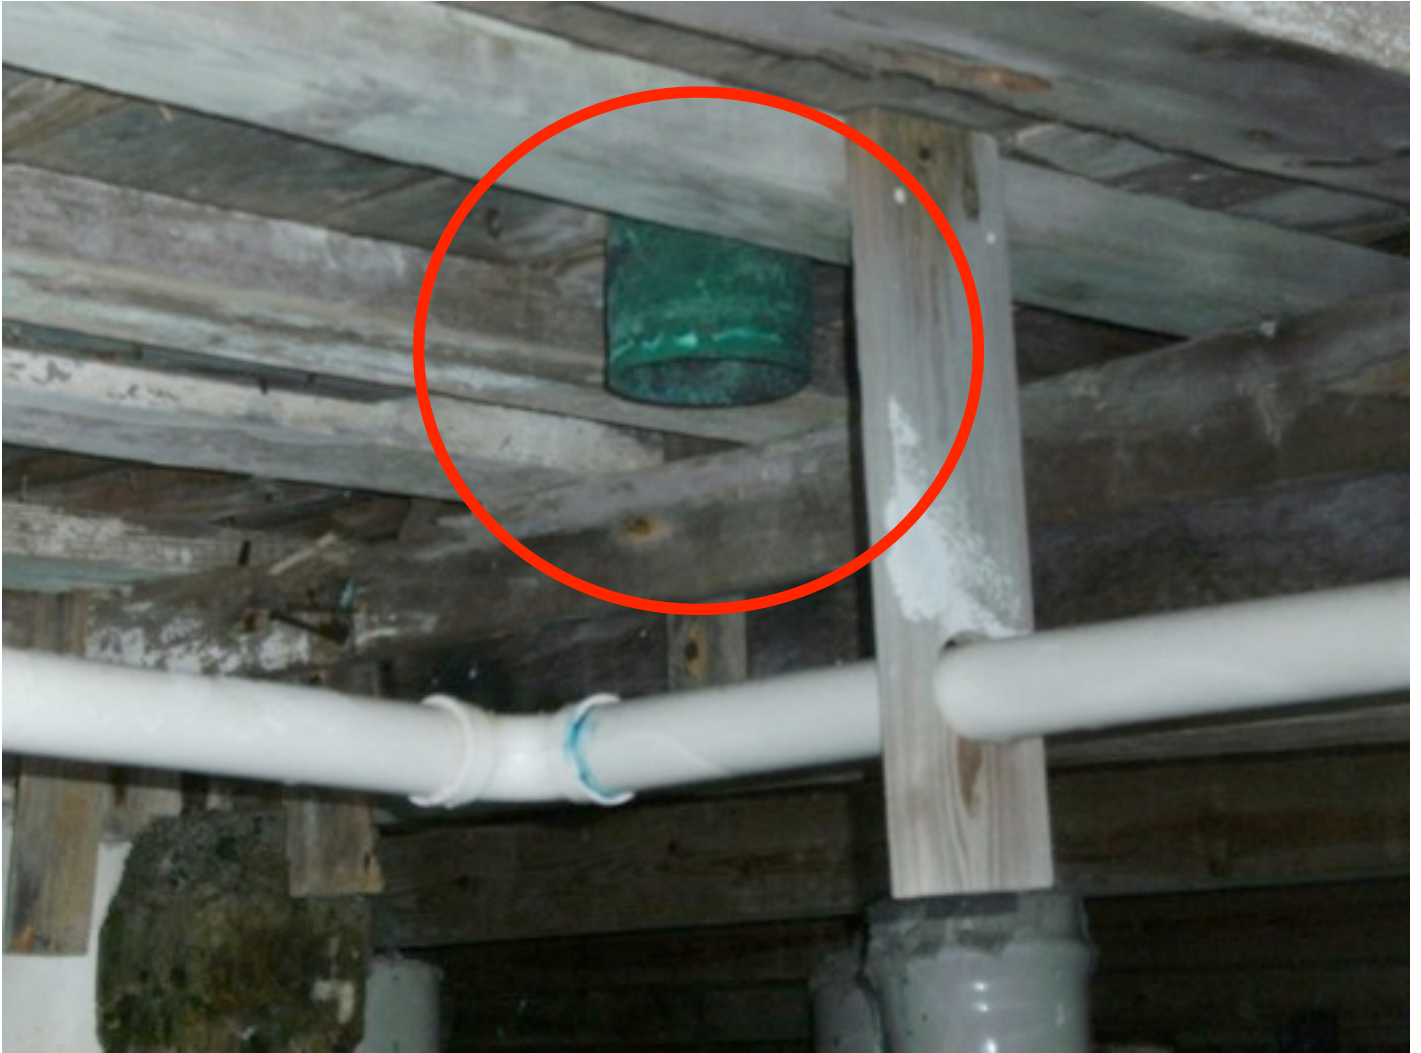
FIGURE 7: Suspicious open drainage. This is a possible pathway to any kind of household contamination including sewage and detergents.

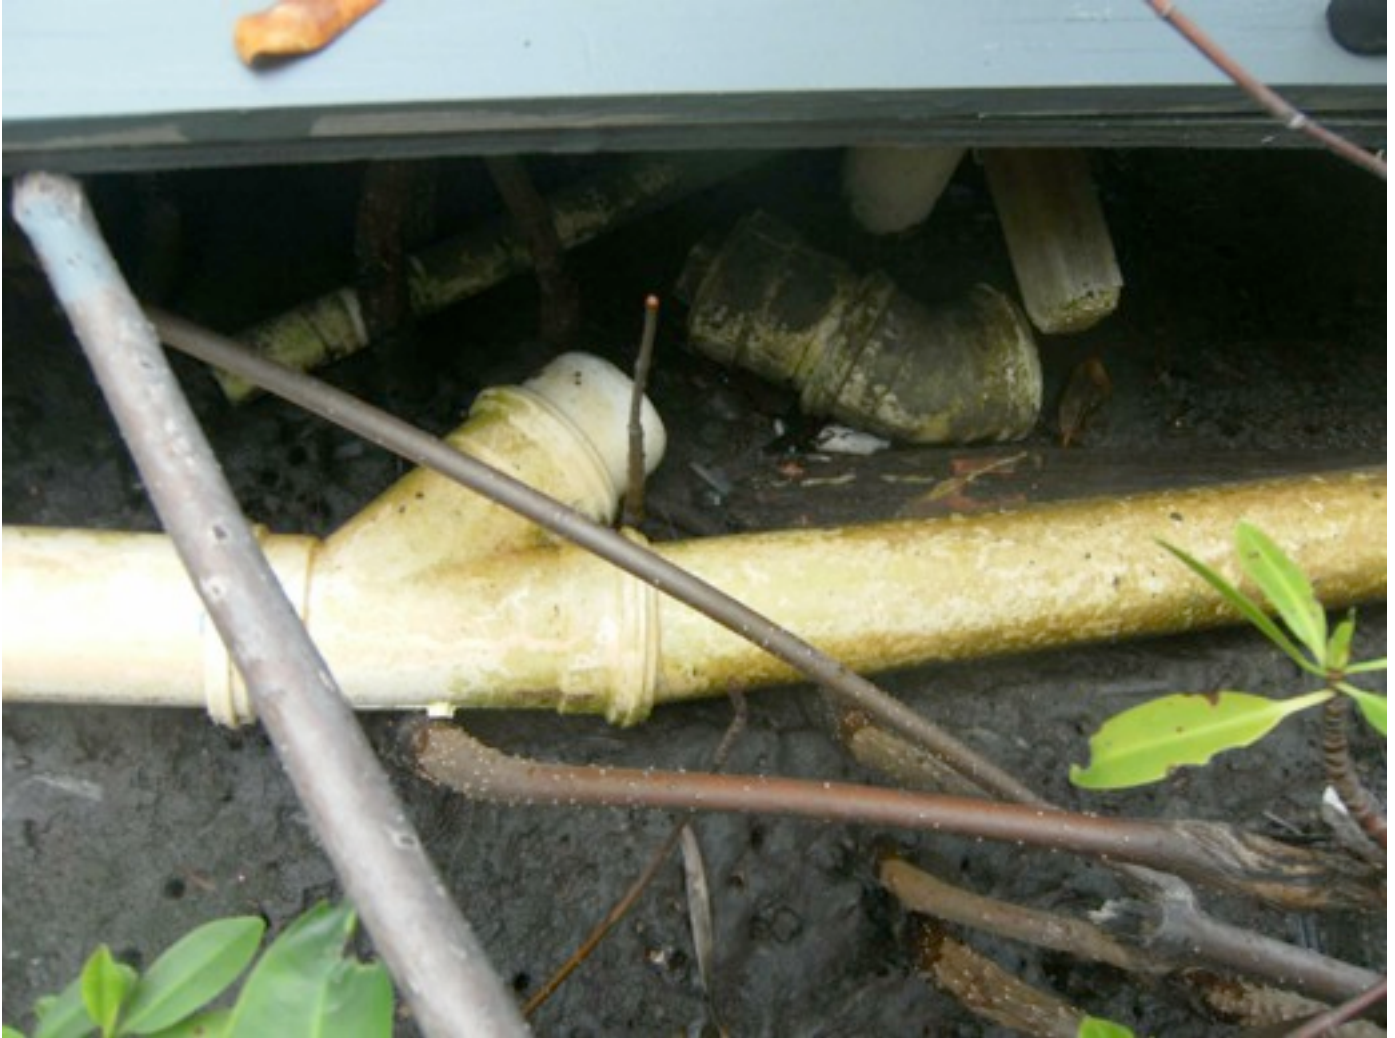
FIGURE 8: An open valve laying on its side (note discoloration) part of the sewage line near a stilt house entrance. These instances represent probable sources of contamination – certainly during heavy use and rain events if not general usage.

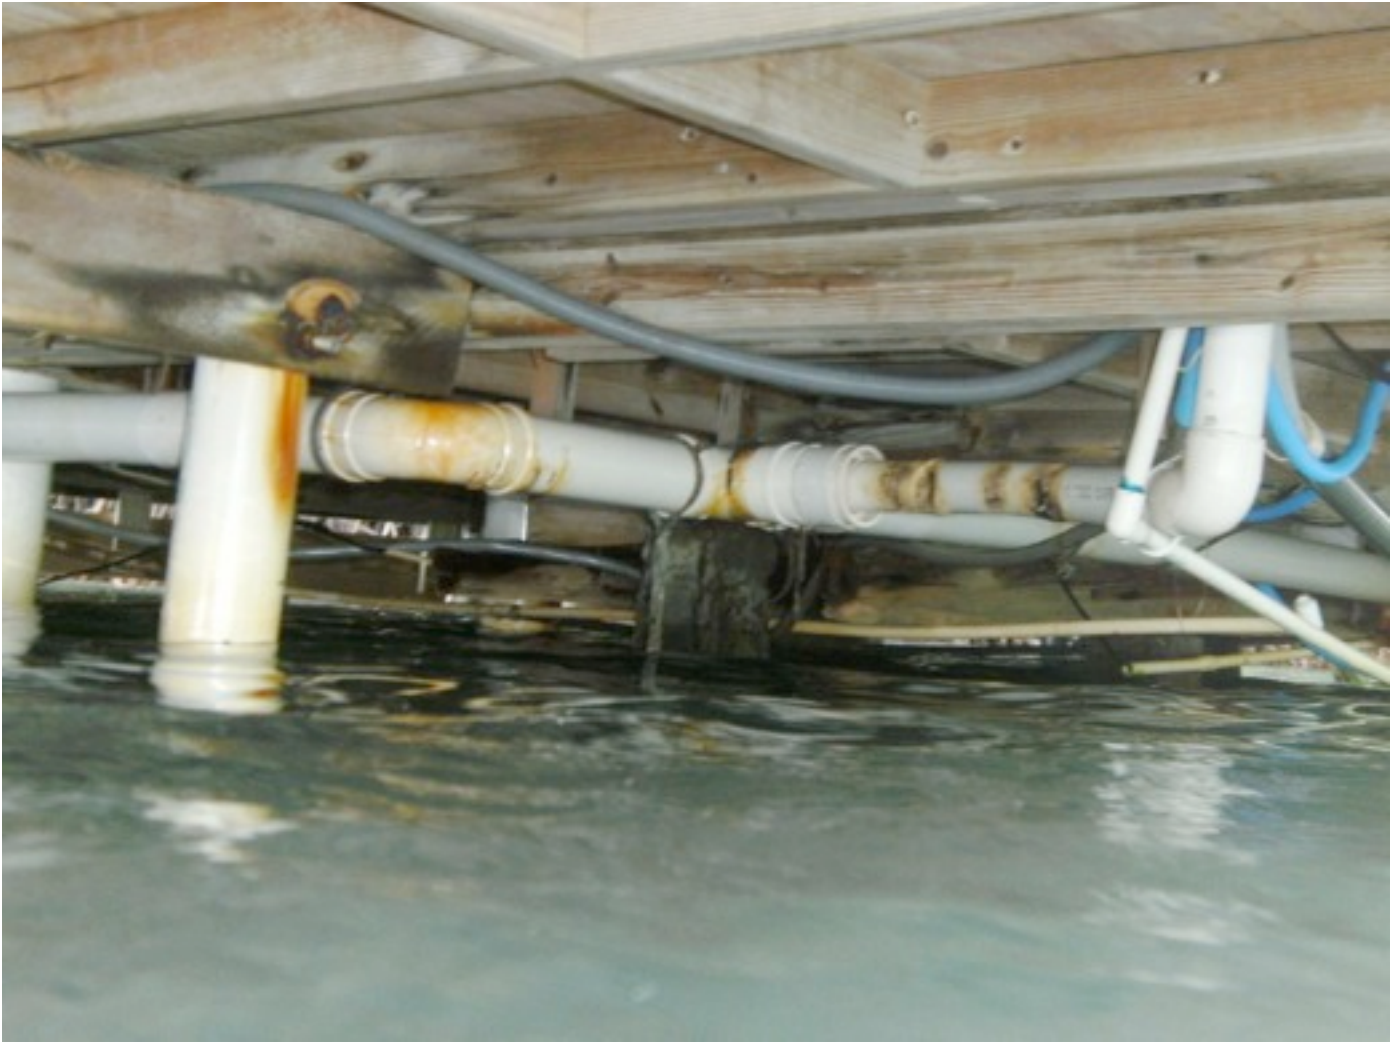
FIGURE 9: Residential sewer pipes with visible damages that can be leaching crude wastewater to the environment.

2. Implement mandatory grinder pumps or composting toilets and 3 year inspections of the sewage lines at the stilt homes. As these homes are currently located in an extremely sensitive ecosystem area and in many instances using a primitive sewage disposal system that defies logic where the pipes are expected to defy the laws of gravity and pressure. This could be implemented with coastal health of both human and marine organisms in mind. We estimate these costs are approximately \$500 - \$1500 per household for composting toilets, and \$1500 - \$5000 for effective pumps and replacement of failing pipe systems where needed. Note a number of homes have already put into place effective pumps and well sealed sewer lines.

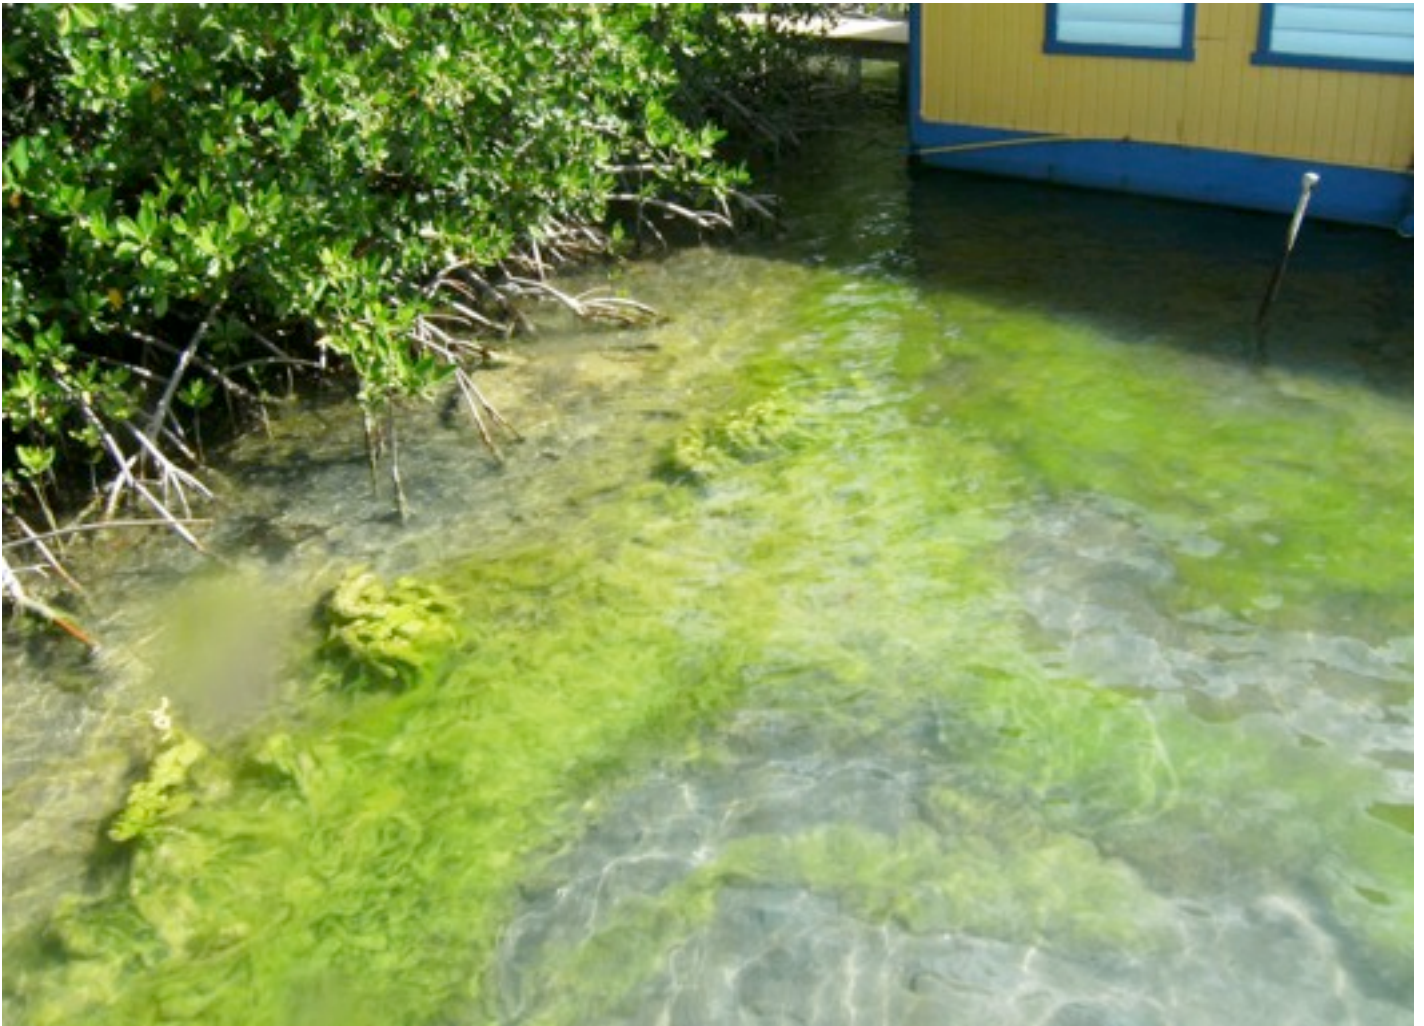
FIGURE 10: Bloom of green macroalgae (genus: *Enteromorpha*) which indicates unequivocal fecal contamination.

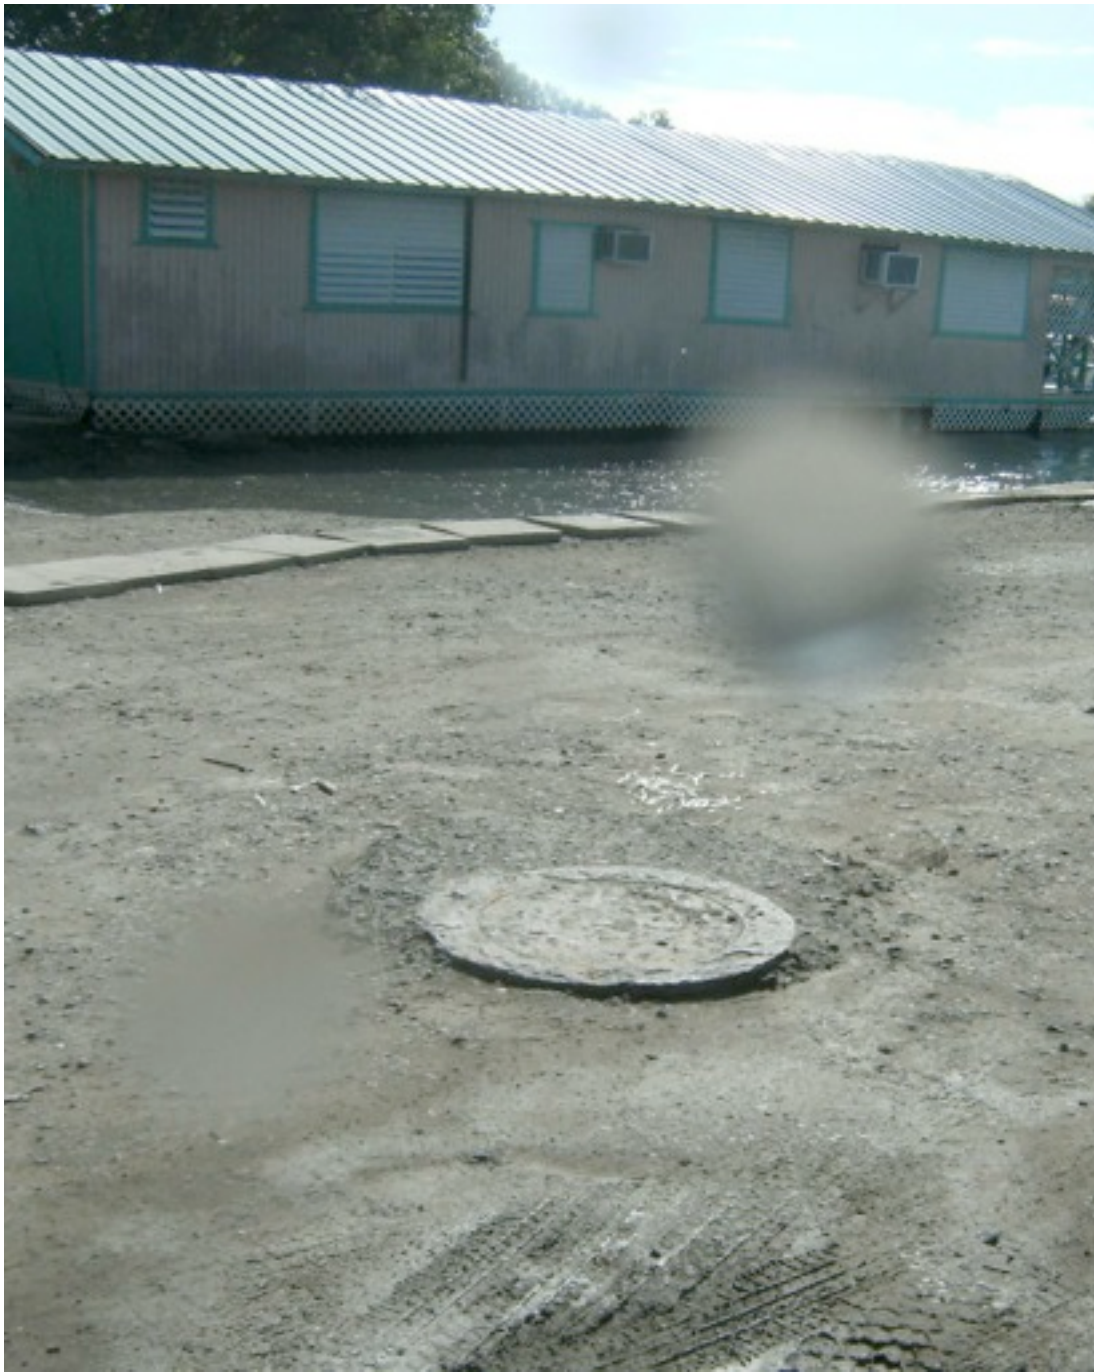
FIGURE 11: Manhole in front of UPR-Marine Sciences Laboratory. This manhole, when over flooded has been identified as a main contributor of raw sewage into the marine environment.

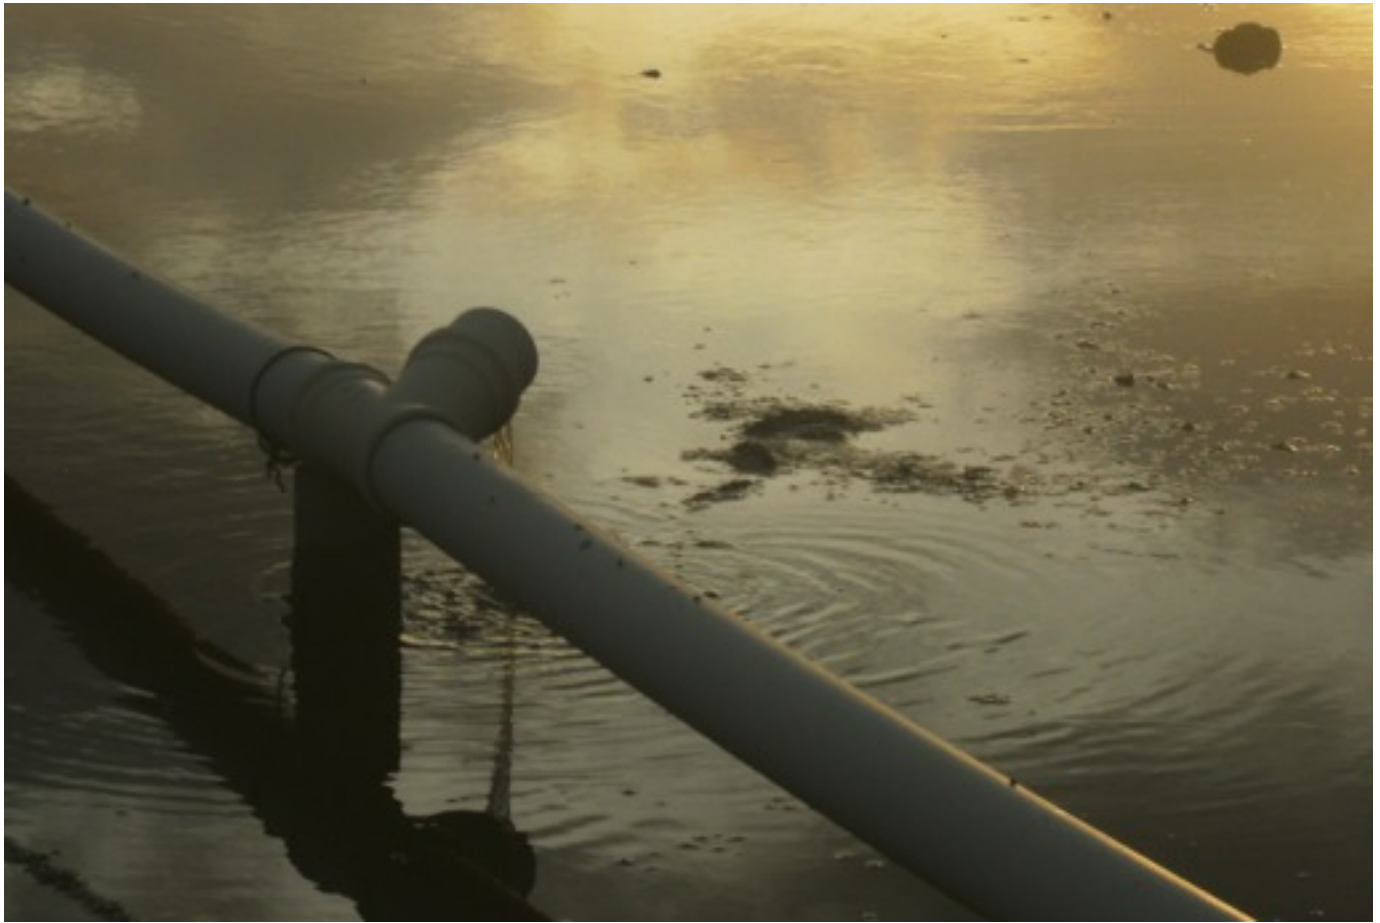
FIGURE 12: Spilling pipe near the mangrove lagoon. This pipe may be back flowing from the main trunk or from the connection of various houses to such a small system. The observed flow was consistent.

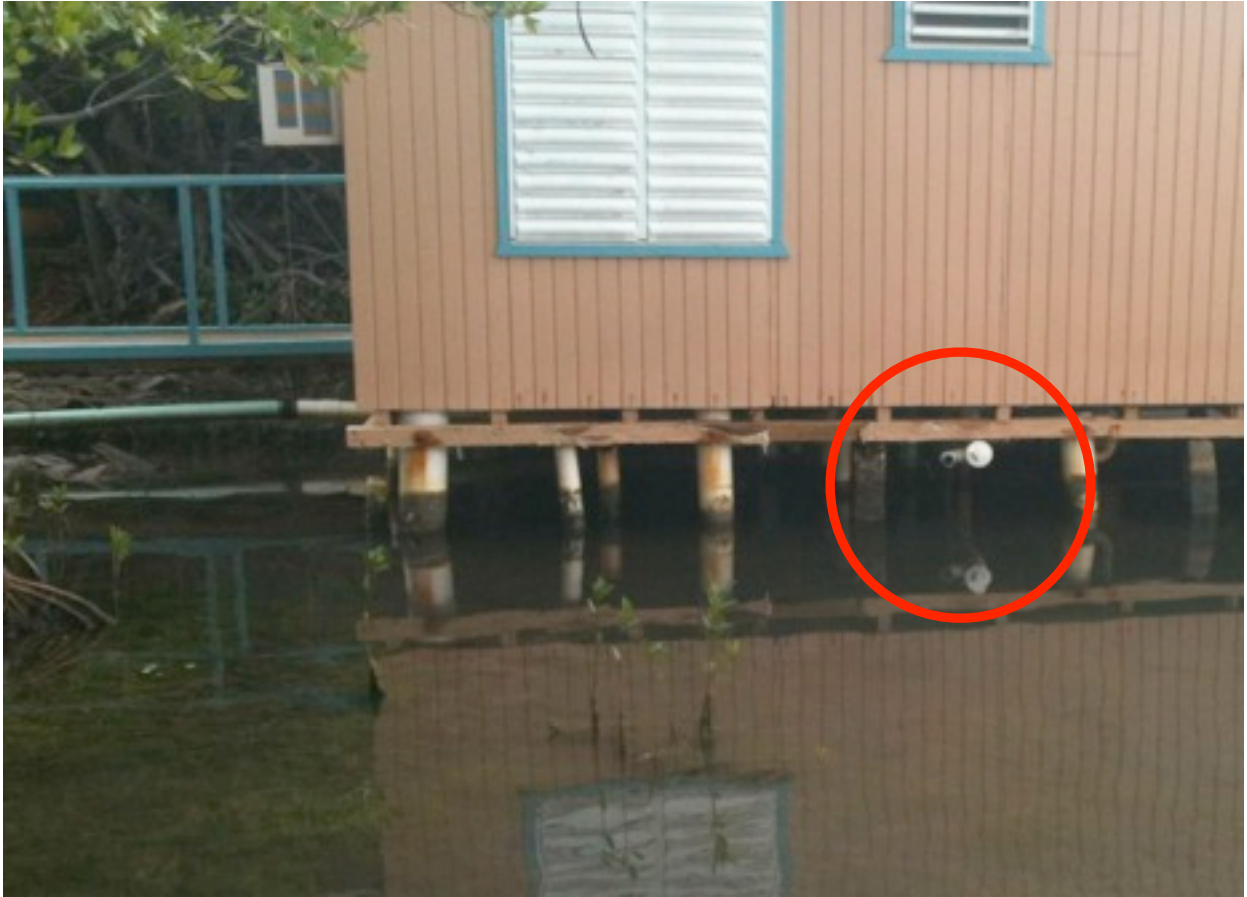
FIGURE 13: Note open pipe next to probable sewage end cap

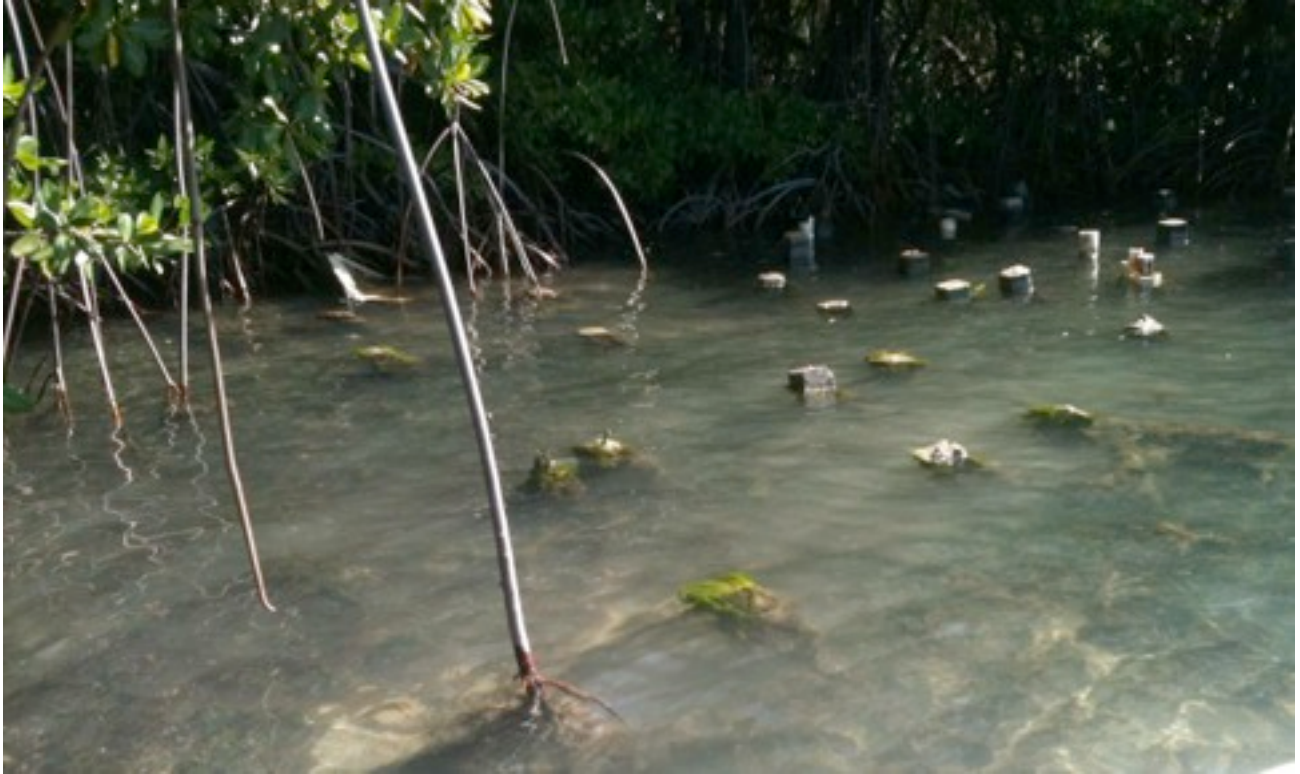
FIGURE 14: Location of past stilt home – note excessive algal growth

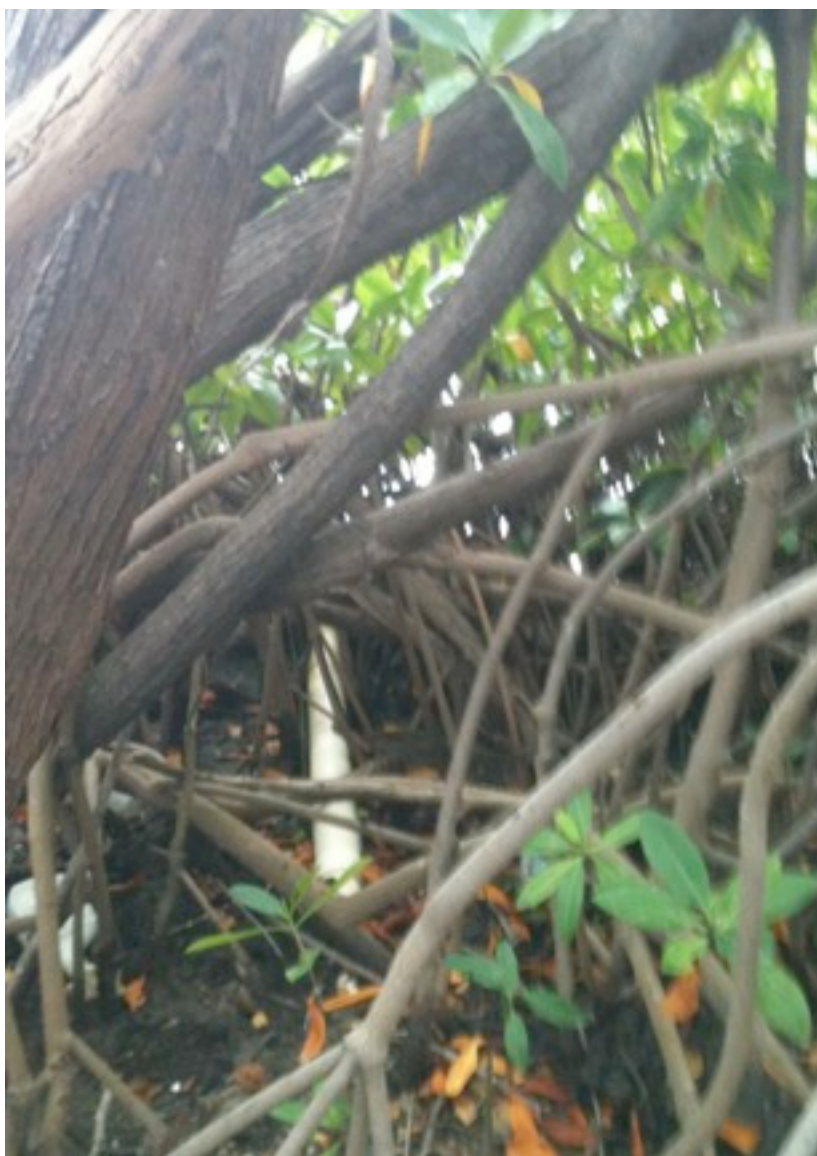
FIGURE 15: Old sewer line for stilt house behind Villa Parguera – open but no longer connected to a house but still connected to sewer line

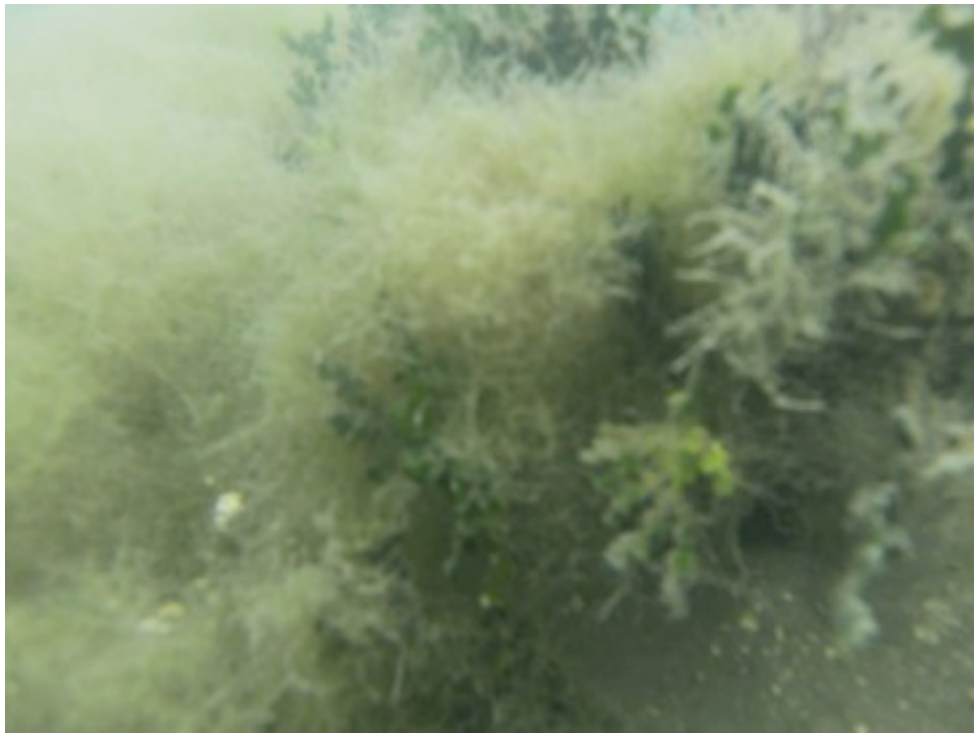
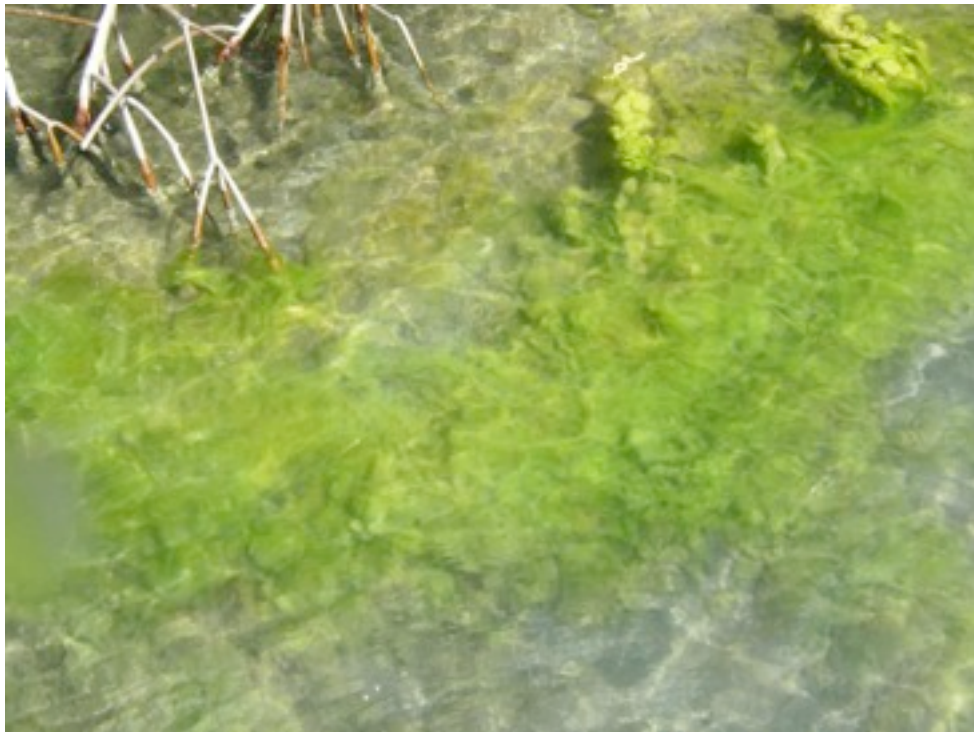
FIGURE 18: Indicator green macroalgae; *Chaetomorpha linum* (top); and *Enteromorpha* sp. (bottom)
