# *CABO ROJO*

## *COMMUNITY WATERSHED ACTION PLAN FOR WATER QUALITY AND CORAL REEFS*

PREPARED FOR  
 NATIONAL FISH AND WILDLIFE FOUNDATION  
 NOAA CORAL REEF CONSERVATION PROGRAM  
 PUERTO RICO DRNA  
 MUNICIPALITY OF CABO ROJO

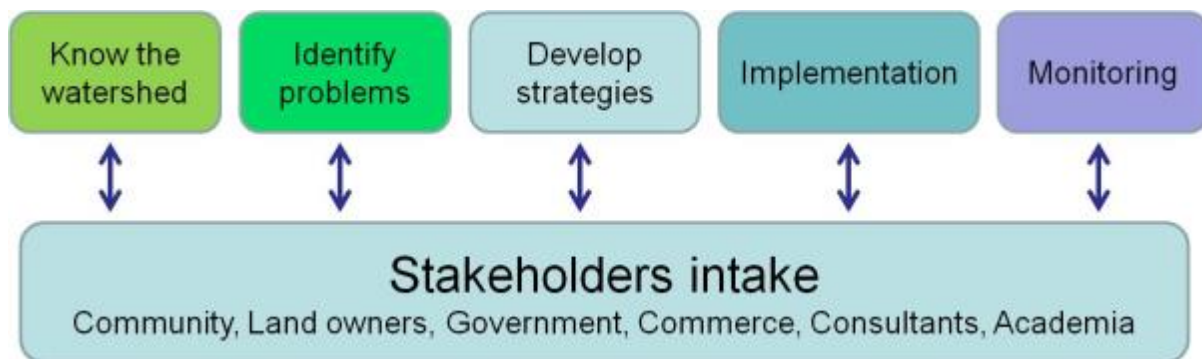
**Figure 2. Conceptual Model of our Community-Based Approach to Watershed Planning and Restoration**

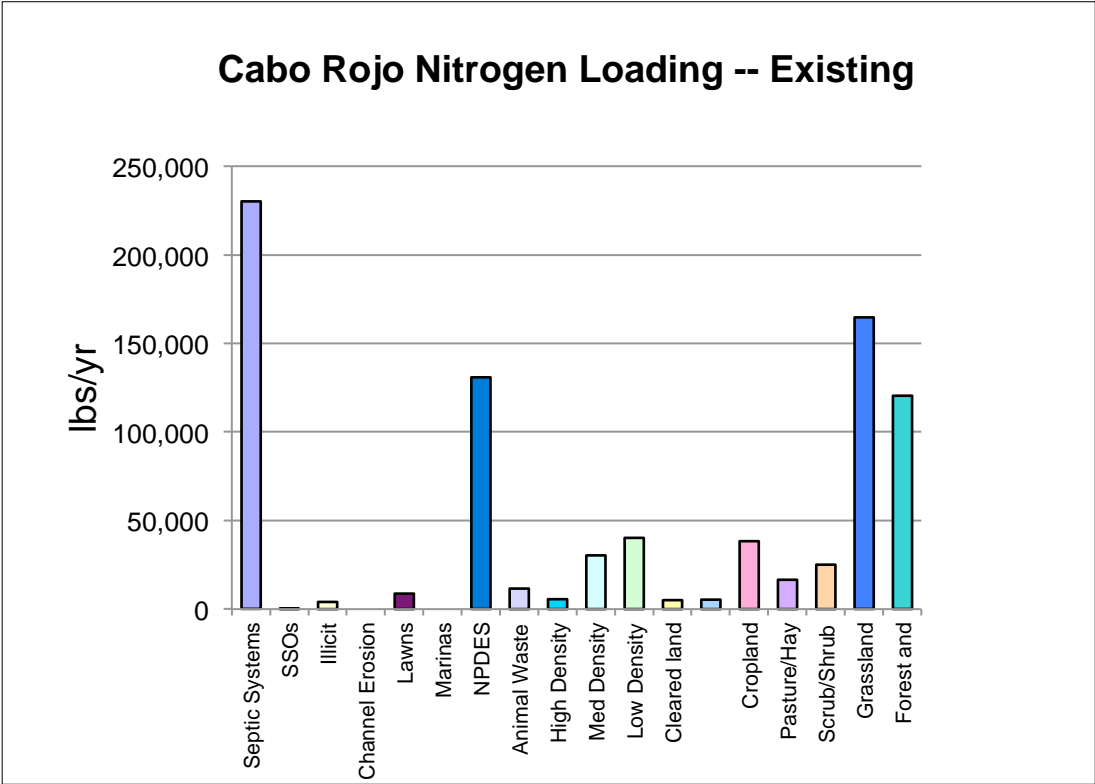
**Figure 3. Nitrogen Source Estimates in Cabo Rojo using the WTM (HDR and MDR refer to High and Medium Density development)**

Several notes are useful when interpreting the sediment and nitrogen loading graphs:

1. The WTM produces relative (expected) loading estimates based on land use, impervious cover and point sources (assumptions can be found in Appendix A-4).
2. The model does not account for situations where sediment loads or nutrients loads may be trapped or processed by wetland or lagoons or through natural denitrifying processes.

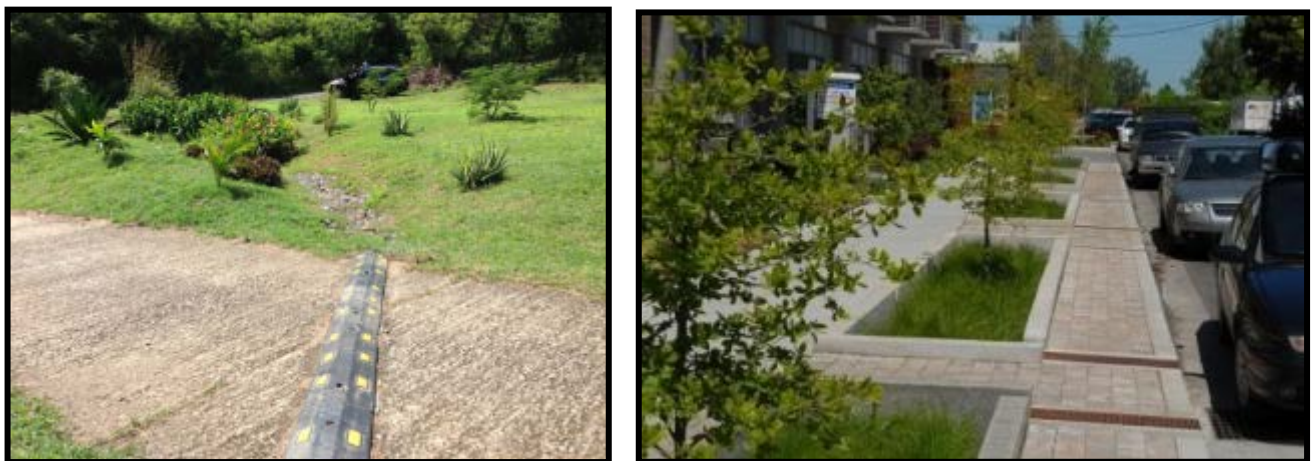
**Figure 12. Rain garden from St. Croix and streetscape biofilters from Santa Monica, CA**

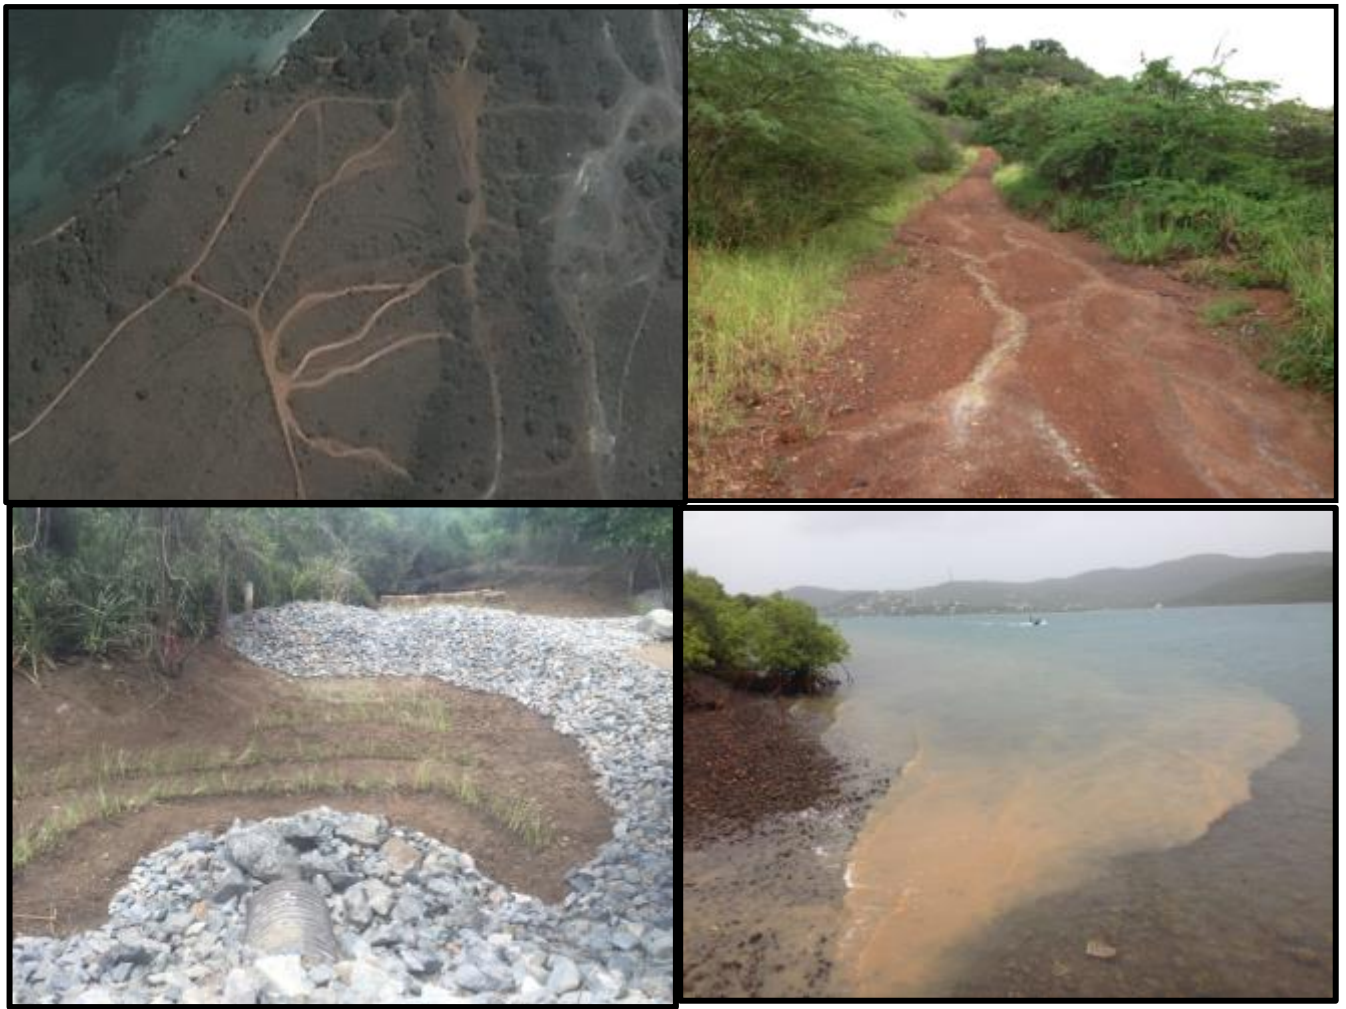
**Figure 13. Clockwise from top left: Dirt roads in Los Pozos near Combate, a significant source of sediment to coastal waters, (right) example of surface rills conveyance over the road surface creating erosion and resulting in fine sediment losses, bottom right sediment reaching coastal waters; bottom left: recently constructed sediment trap in Cabo Rojo to capture sediment before it enters Boquerón Bay**

Stabilization of bare soils (Figure 13) involves the rapid re-stabilization of vegetation and generally a transition to more native and stable forms of vegetation. One effective way to re-establish vegetation in an area is to utilize hydroseeding followed by watering to rapidly transition to a more stable vegetated system where runoff is reduced. Dirt roads are stabilized using methods to remove water from the road and reduce erosion. These include concrete or dirt cross-swales, check dams and sediment traps. The recommendations for dirt road and bare soil stabilization are found in Table 6. Maps are found toward the end of the section in Figure 16. Each of the bare soil restoration projects is important in its own right due to the high loads associated with bare soils.

It should be noted that all exposed soil and dirt roads transport sediment at a rate of 5x to 100x the natural transport rate from a forest or a field, so maximizing the amount of roads and bare soil areas treated is a critical element of the watershed plan, as is reducing the impact of future road development.

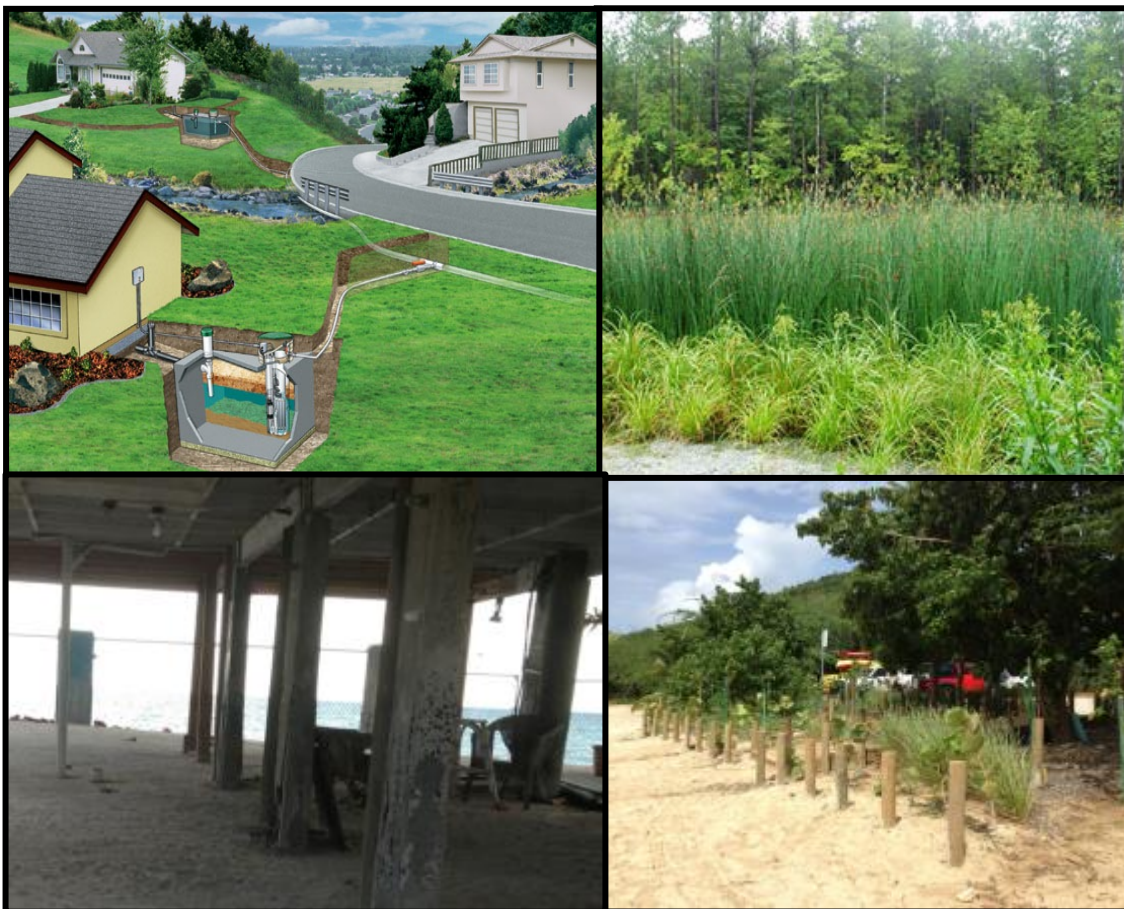
**Figure 14. Top (Pump and treat system where effluent is pumped from homes to a constructed wetland or landscaped area (right); Bottom: (left) sewage effluent enters a septic system in the beach berm in Combate, (Bottom left) a passive low cost approach to addressing this issue is to restore a vegetated beach berm to include the use of vetiver and native species such as sea grape (uva playa) as has been done in Tamarindo Beach in Culebra**

into the groundwater and maximizing nutrient removal via vegetation and uptake or by promoting denitrification. Examples of a pump and treat system are found in Figure 14 - the effluent can be pumped to a constructed wetland such as is shown in the top right of Figure 14. These efforts should be focused in areas where space is limited between the septic system and the coast and where septic failures are occurring and connecting to the PRASA sewer system is not an option. Examples would be to use these practices at small hotels and restaurants in places like Joyuda and Combate. Other more passive systems are also possible particularly where space is limited such as structures located on the beach itself – in this example from Combate septic systems are located in the beach berm. Restoring the beach buffer with native plants and vetiver (which can grow its roots to 3-4 meters deep) to attempt to intercept contaminated groundwater before it enters the nearshore waters with a dual benefit of also helping protect the shoreline from erosion by allowing the beach berm to aggregate sediment.

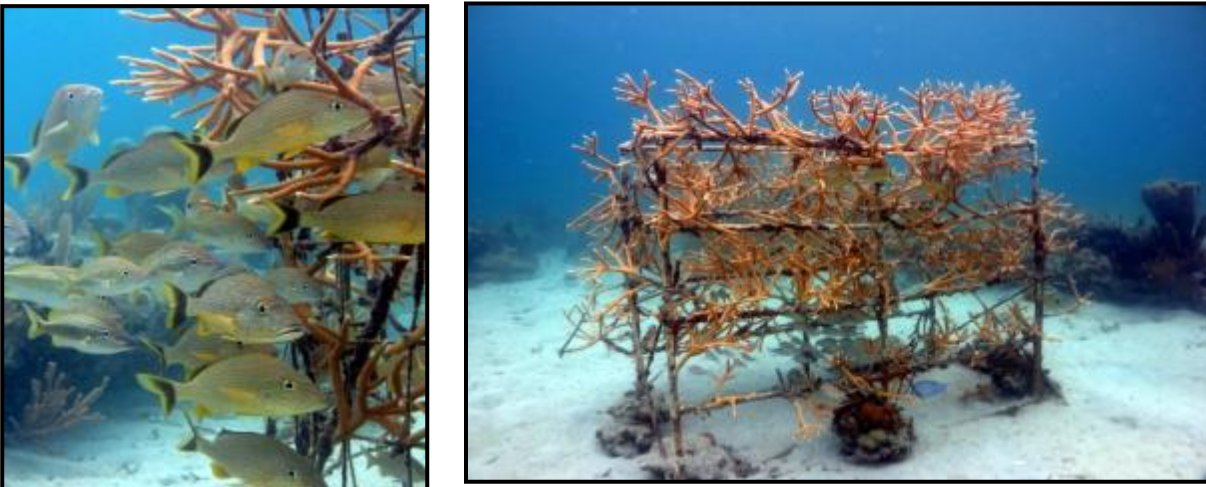
Figure 15. Coral restoration efforts in Tamarindo (Photo credit: CESAM)

Coral restoration involves the propagation of corals, in this case Staghorn coral (*Acropora cervicornis*) (Figure 15), and to a lesser extent other species including Elkhorn coral (*Acropora palmata*). These species have been decimated in the Caribbean - over the last 30 years there has been an 80 – 90% decline. Coral Restoration could be pursued in the greater Cabo Rojo area particularly in combination with implementation to control land based sources of pollution. Similar efforts have taken place in other reef areas in Puerto Rico including the first nursery site in Culebra. The goal of coral restoration efforts and out planting of corals has been to re-establish *Acropora* populations. The community project of Coral Reef Rehabilitation and Aquaculture in Culebra began in 2003 and has been led by the Society of Marine Environment (SAM) and Coralatons in collaboration with the University of Puerto Rico Center for Applied Tropical Ecology and Conservation (CATEC). Locations that could be evaluated for nurseries include the areas that have the best existing conditions within the nearshore areas, mid-shore and offshore areas.

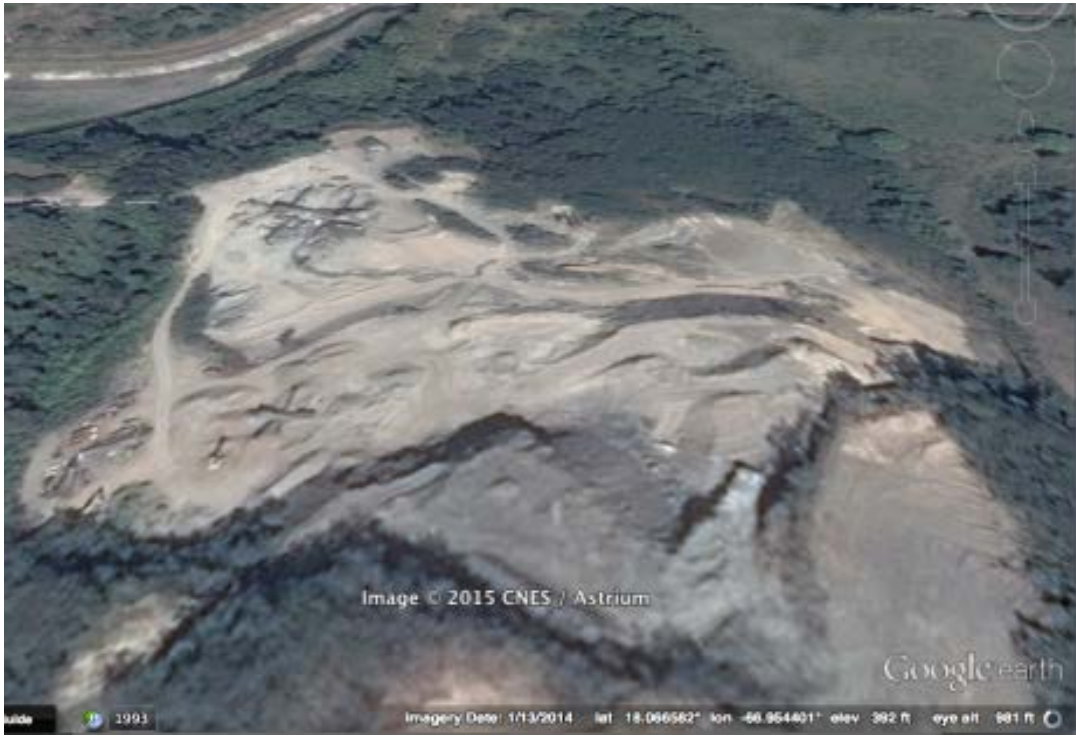
Figure 16. Typical quarry occurring on slopes with no visible sediment control basins or ponds.

At least 9 quarries and extraction operations (Table 6 and Figure 18)) are present in the Guanajibo watershed of Cabo Rojo – most of these operations have limited best management practices based on field visits to sites as well as local testimonials (Figure 16 shows a typical quarry in the subwatershed). Proposed is a project that would work with quarry owner/operators to minimize runoff and impacts to downstream waters including sediment and stormwater controls, pollution prevention plans and outreach and education. EPA, EQB should be involved in providing oversight and regulatory encouragement of quarry owner/operators to minimize their impact as well as funding to help initiate the program and support for helping them achieve higher levels of treatment and pollution prevention. A similar program in American Samoa has created a large sediment basin for a quarry that was impacting downstream coral reefs (Figure 17).

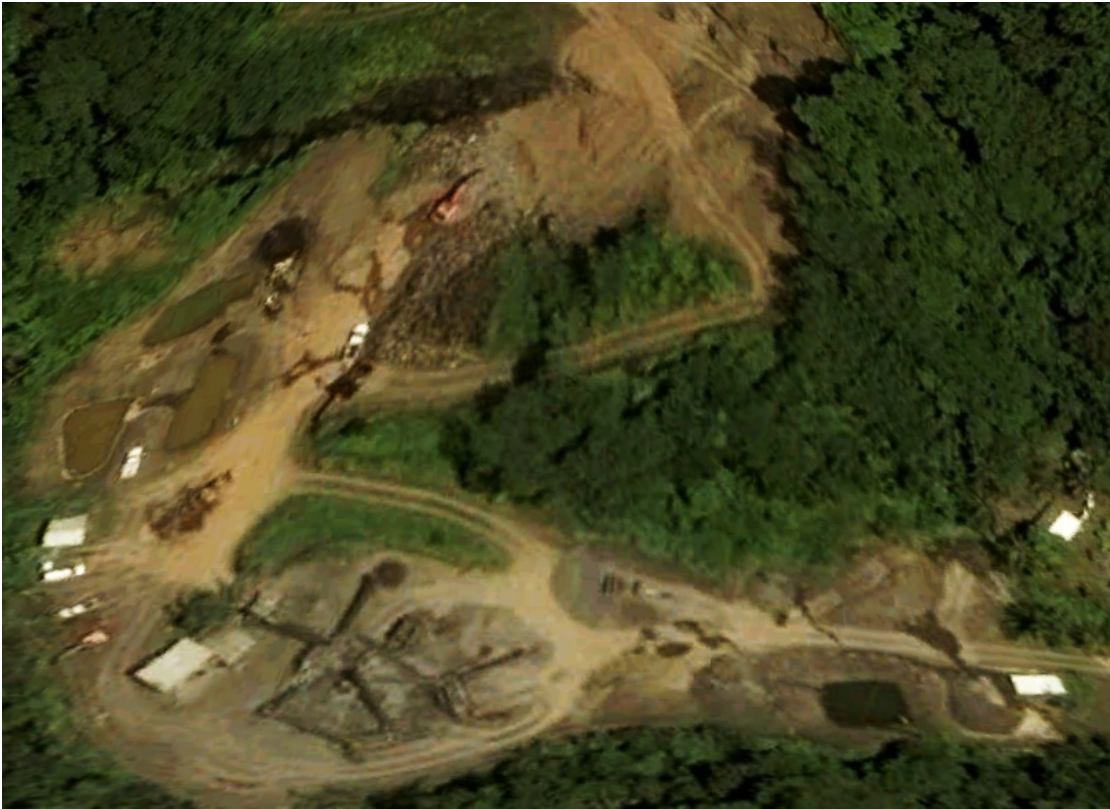
Figure 17. Quarry sediment basin (in lower right of photo) for a project in Faga’alu, American Samoa

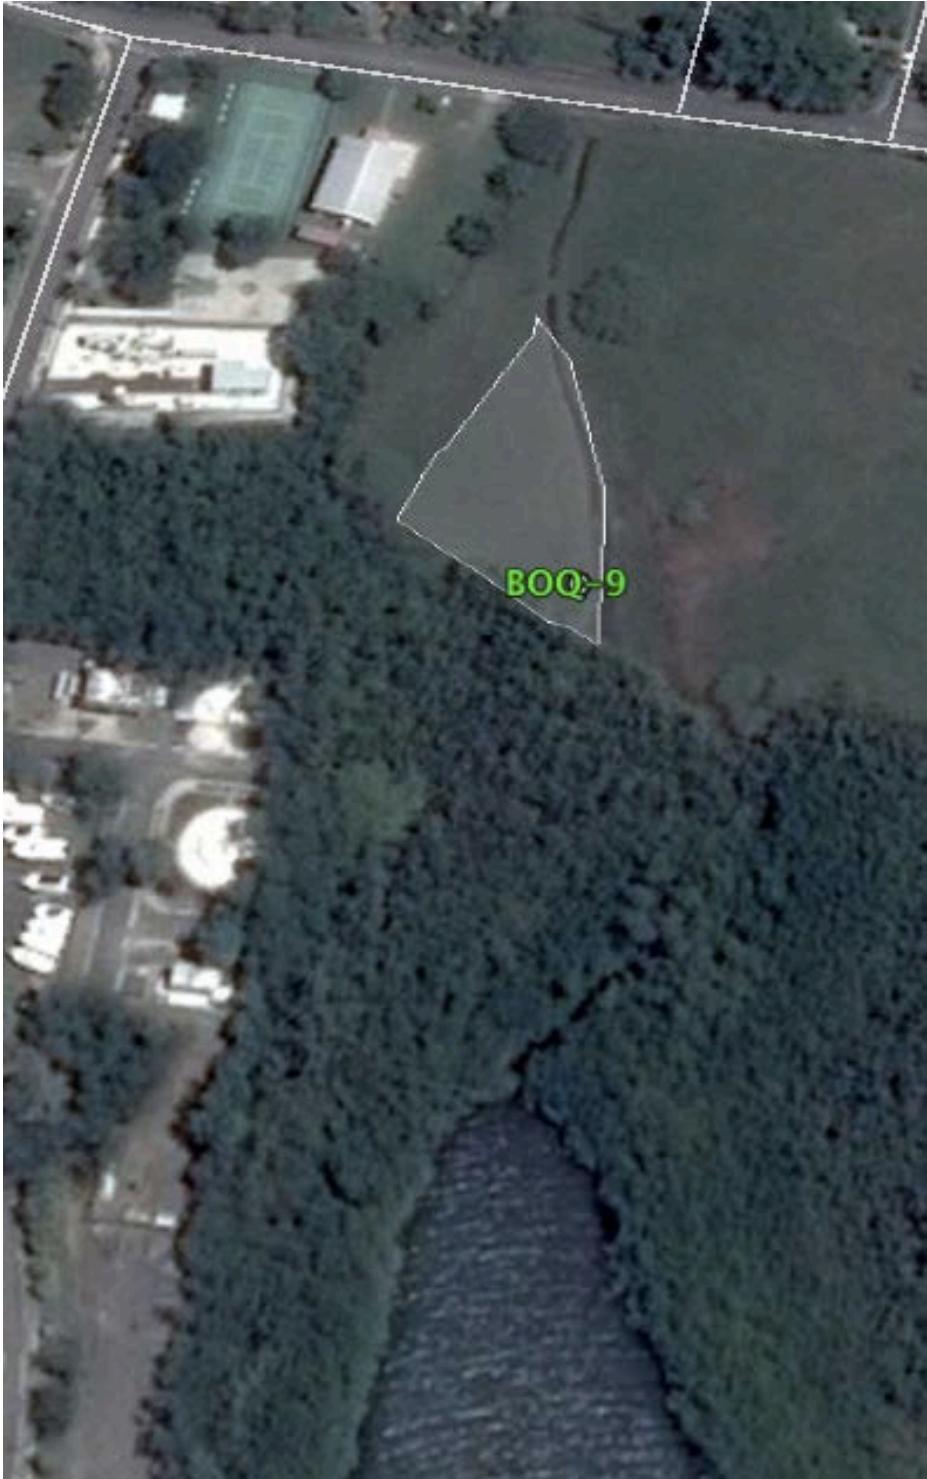
Location for a treatment wetland to address uncontrolled stormwater and elevated nutrients and bacteria

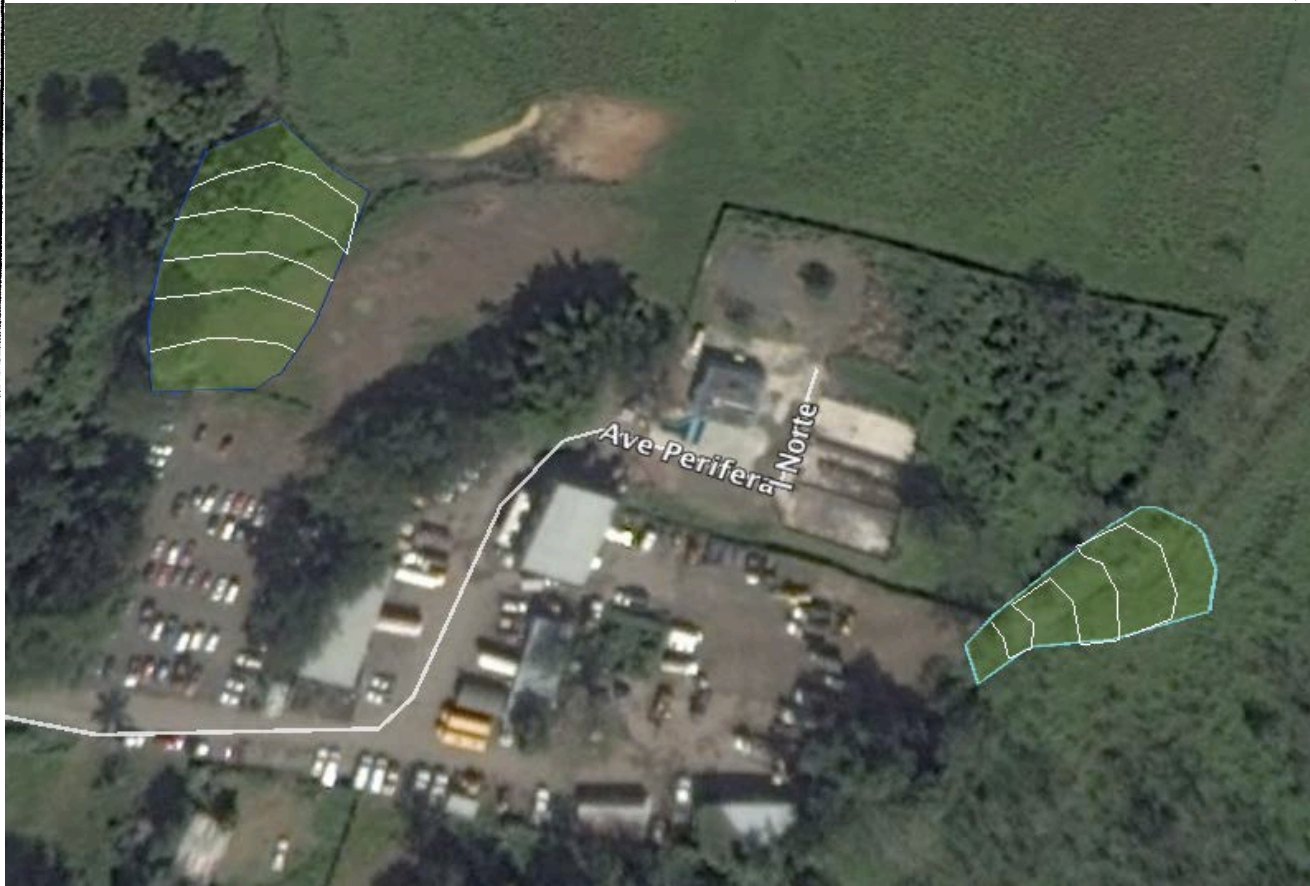
Two potential locations for stormwater wetlands at the existng public works facility in Cabo Rojo

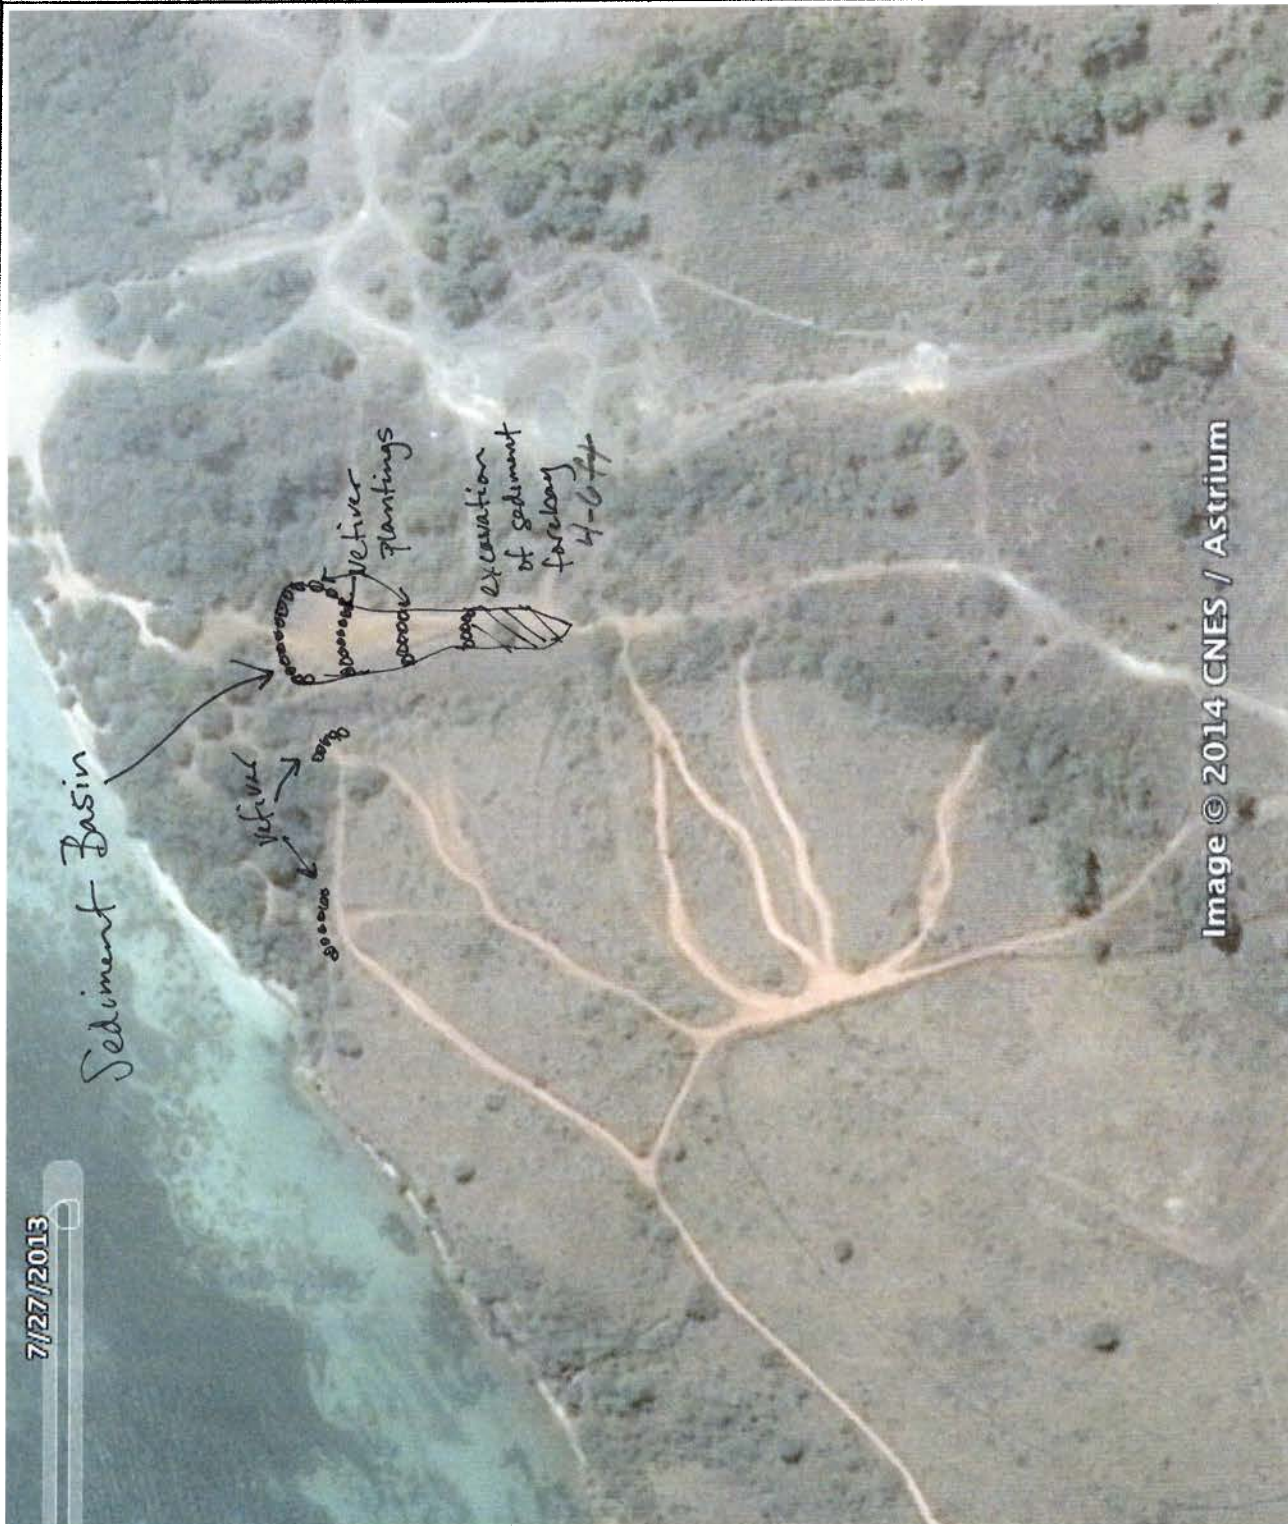
DATE: 5-14-2014 SUBWATERSHED: Combate UNIQUE SITE ID: COM 4/COM5

≈ 20+ acre drainage w 4-track usage conveying large amounts of sediment to nearshore waters					
Existing Head Available and Points Where Measured:					
Need survey					
<b>PROPOSED RETROFIT</b>					
Retrofit Volume Computations - Target Storage:			Retrofit Volume Computations - Available Storage:		
Suggest sizing for 3in rain event 4.2 ac/ft on 1.25 acres			Would need survey + precise D.A. Calc		
Proposed Treatment Option:					
<input type="checkbox"/> Extended Detention	<input type="checkbox"/> Wet Pond	<input type="checkbox"/> Created Wetland	<input type="checkbox"/> Bioretention	Sediment basin	
<input type="checkbox"/> Filtering Practice	<input type="checkbox"/> Infiltration	<input type="checkbox"/> Swale	<input type="checkbox"/> Other:		
Describe Elements of Proposed Retrofit, Including Surface Area, Maximum Depth of Treatment, and Conveyance:					
Surface Area Est. 1.25 acres Max Depth 4-ft

SKETCH

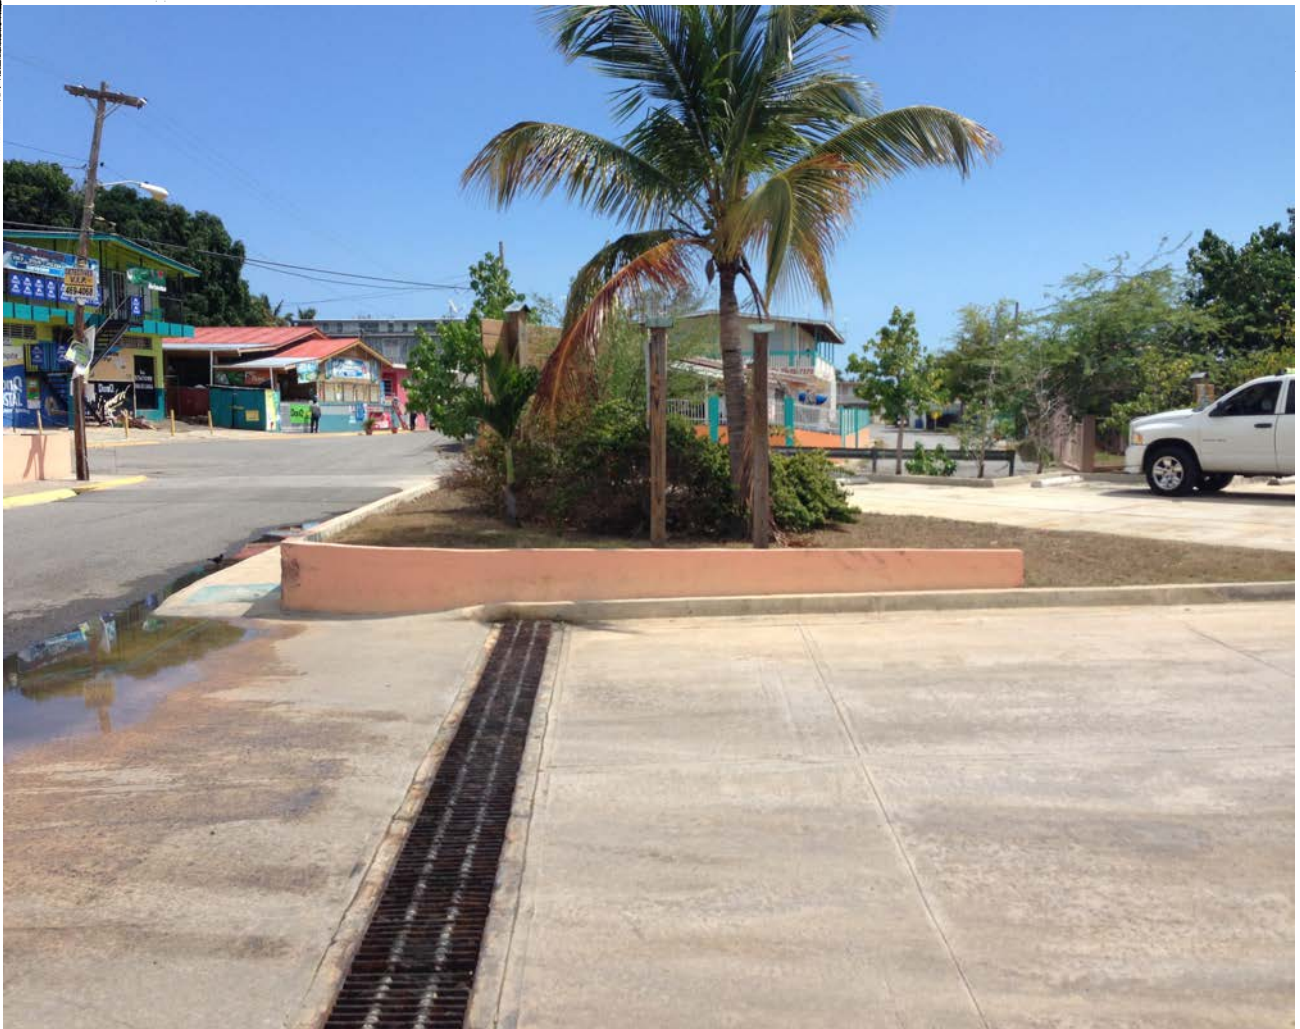
Convert clogged stormwater practice to surface sand filter within the existing vegetated island -- see overview of both practices on next sheet

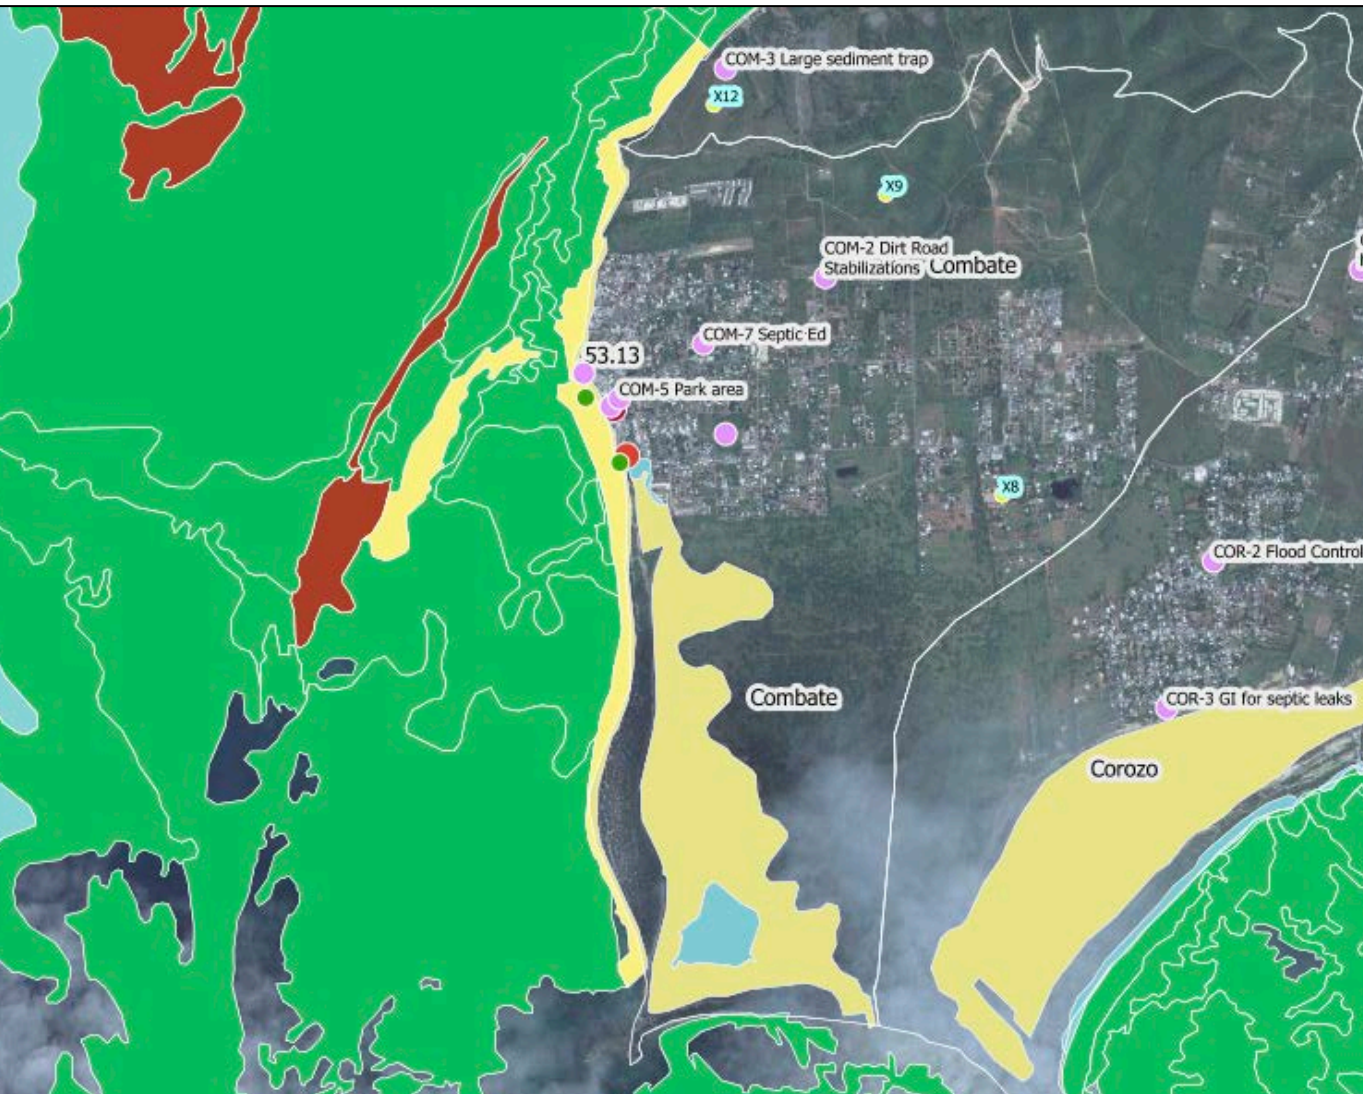
# Combate

- Restoration Project Layer
- Bare soil locations
- Quarry and mining related loca...
- Tidal Water Quality Stations
