**Reduction and Control of Sediment-Laden Runoff to Coastal Waters through the Implementation of Best Management Practices (BMP's), Coastal Habitat Rehabilitation and Delimitation of Public Access at Culebra, Puerto Rico**

**FINAL REPORT**

August, 2015

*Projects toward the implementation of the Culebra Community Watershed Action Plan for Coral Reefs and Water Quality*

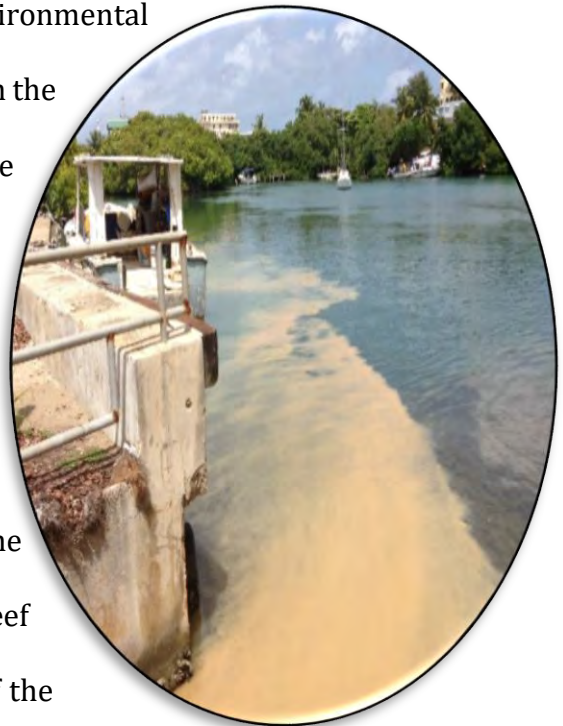
**Figure 3** (Top). Runoff with fine sediments and beach erosion problems at Zoní Beach prior stabilization. Picture from the UPRM Sea Grant Program Marejada Magazine. **Figure 4** (Bottom). Sediment plume out to the Lobina Channel from the town site prior stabilization.

Zoní was selected as a high priority location due to the erosion occurring on the road network driving down to the beach and of the parking lot which allowed conveyance of untreated stormwater into the nearshore marine environment and coral reefs (Figure 3). The Townsite was identified as a priority due to extensive sediment transport from a dirt road and conveyance of stormwater runoff in a small eroding channel out to the Lobina Channel (Figure 4).

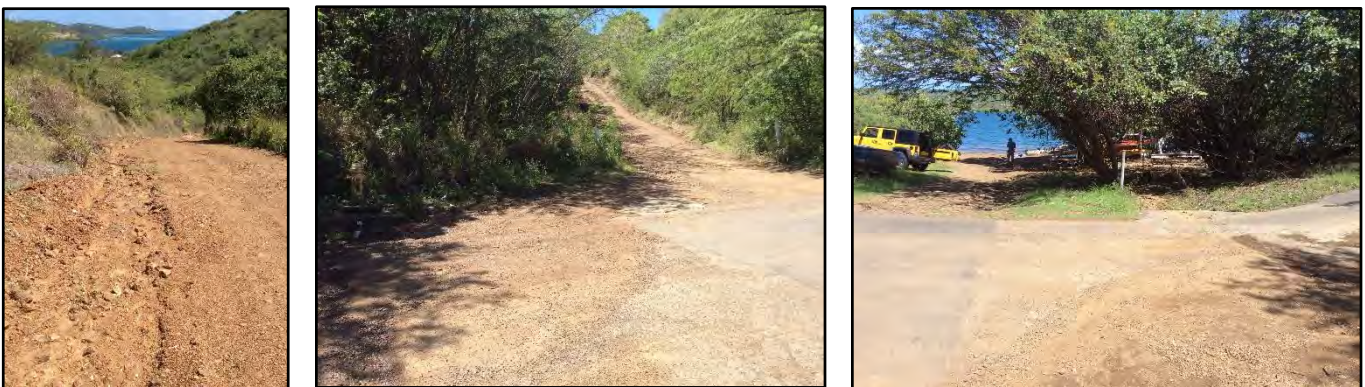
**Figure 5.** Example actual unstable dirt roads in Culebra.

Increased levels of land-based sediment loads associated with coastal development is one of the most important factors affecting coastal marine ecosystems in Puerto Rico. Puerto Rico coral reefs are among the most threatened marine ecosystems in the Caribbean. High sediment loads to marine environments resulting from poorly maintained dirt roads without the installation of proper management practices is a very common problem in Culebra (Figure 5).

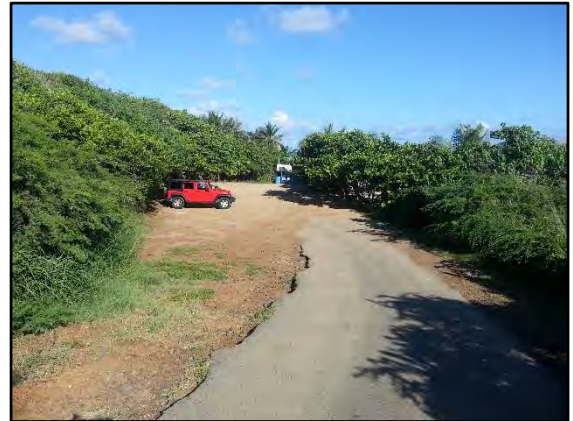
Figure 8. Parking lot prior stabilization.

The problems identified in Zoní beach were mainly associated with runoff generated from the dirt parking lot (Figure 8) and the unpaved road network that provides vehicular access to areas adjacent to the beach (Figure 9). Existing infrastructure was in a critical state of disrepair with rutting and small undesirable watercourses conveying runoff and sediment down to Zoní Beach (Figure 10). The dirt parking lot covers approximately 500 m<sup>2</sup> and vehicles had direct access to the permanent vegetation areas of the beach. The lack of proper planning and management of erosion and sediment led to an increase in contamination of the beach with sediment and pollutants associated with motor vehicles. After several field evaluations, input from the local community, DNER, FWS and NOAA the following restoration components were established (Figure 11):

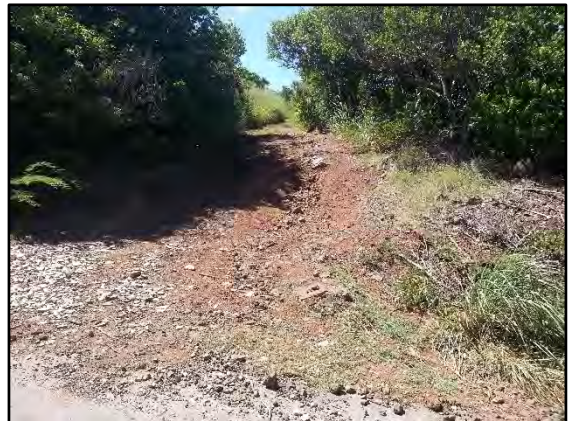
Figure 9. Dirt road prior stabilization.

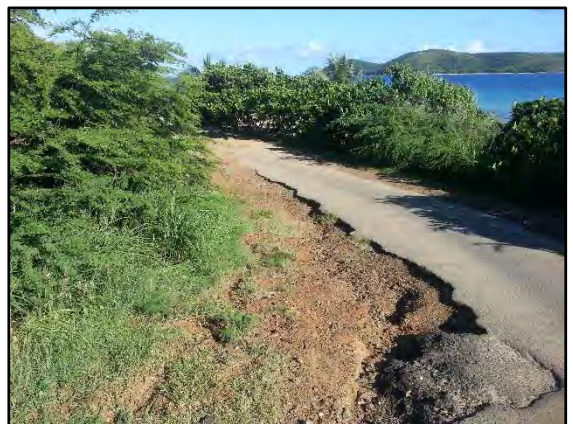
Figure 10. Undesirable watercourses prior stabilization.

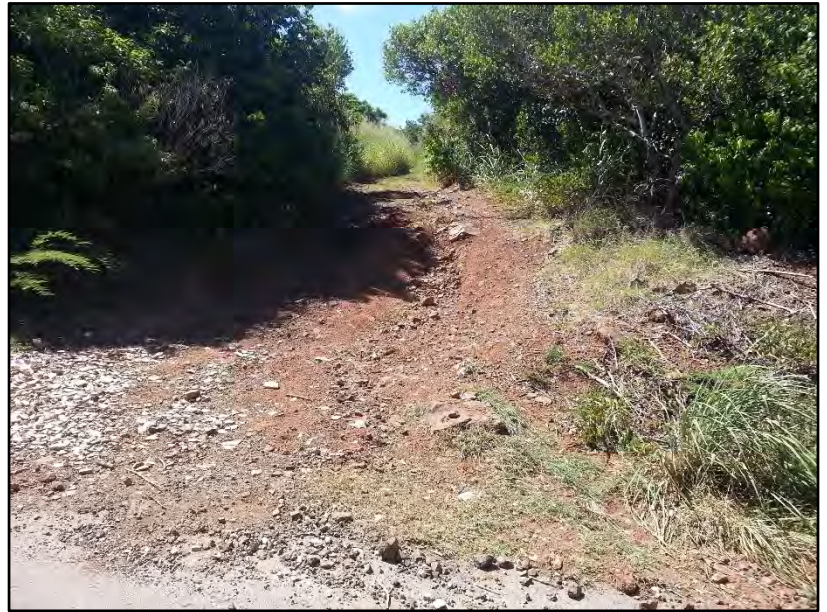
Figure 12. Dirt road prior stabilization.

to Zoni Beach. The stabilization of this dirt road has significantly reduced the amount of flow and the velocity of water and sediment sent downhill. Water had converted this road into a drainage channel increasing the velocity of the water running towards the road to Zoní Beach (Figure 12). Restoration work at this site consisted of diverting runoff water to forested areas in 4 to 6 segmented locations. To stabilize this section of road, we installed dirt swales, thus reducing flow and diverting water to adjoining forested areas.

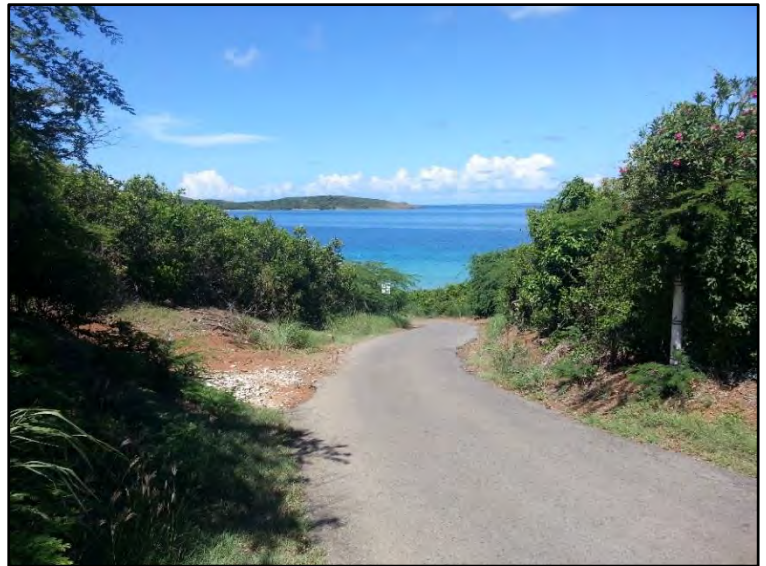
Figure 13. Paved road prior stabilization.

Previous to our intervention the paved access road served as the flow pattern of runoff to the parking lot area (Figure 13). In order to reduce runoff and dissipate its energy, water was conveyed to intercepts at 3 locations on both sides of the road that will

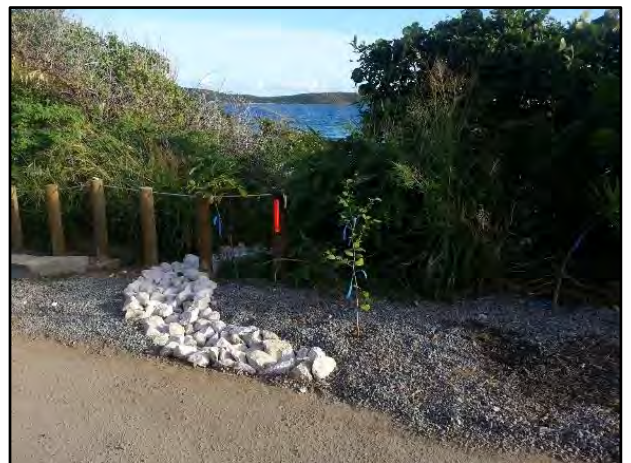
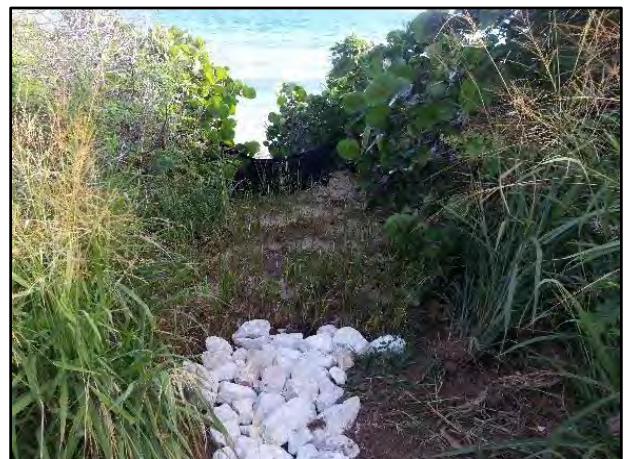
Figure 14. Flow intercepts.

break up flow paths and reduce concentrated flow of runoff over the parking lot (Figure 14). The excess runoff will be forced to a riprap and Vetiver swale built parallel to the south side of the road to take water off the road and it will end in a wider concrete bio-filter system with built-in large

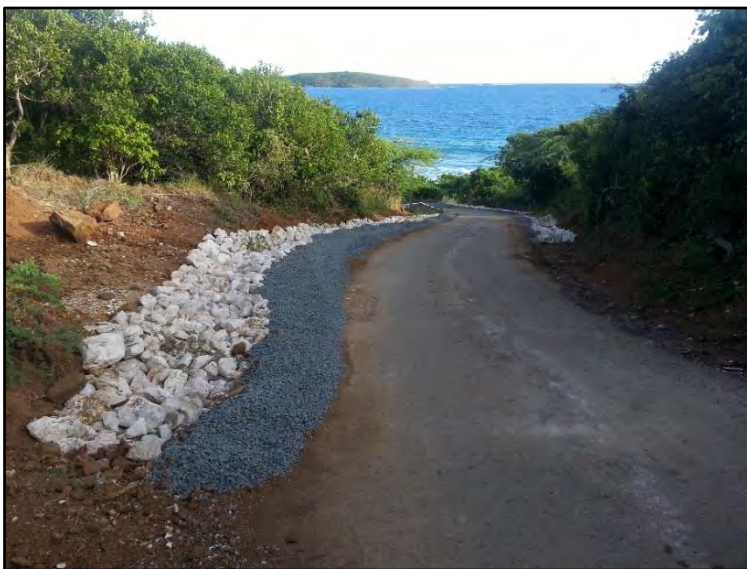
Figure 15. Riprap and Vetiver Swale.

stones that promote sheet flow towards the sediment trap after passing through several lines of Vetiver grass (Figure 15). Damaged section of this road were repaired to prevent soils to be carried to the stabilized parking lot (Figure 16).

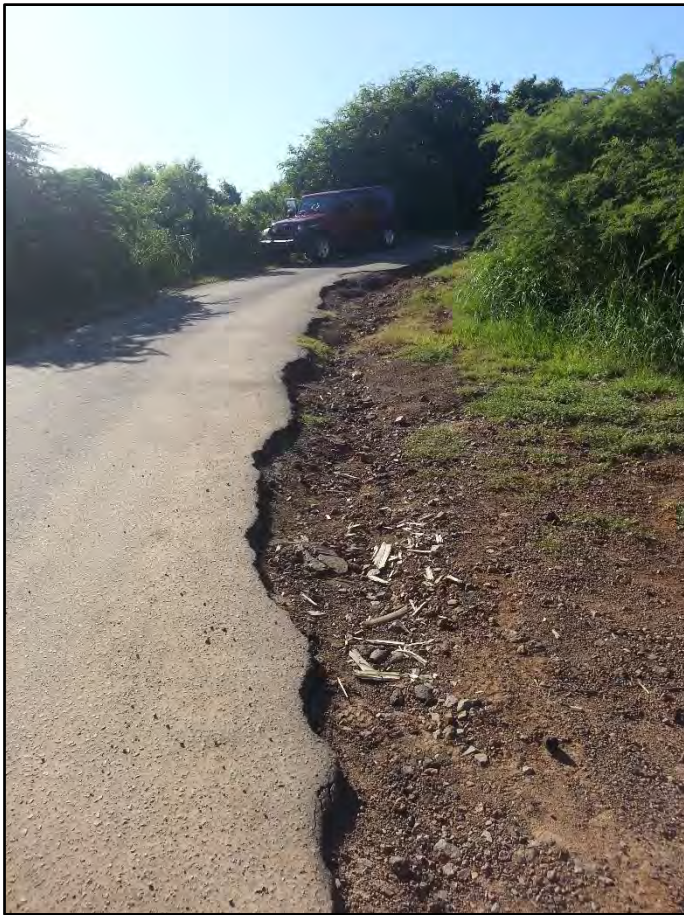
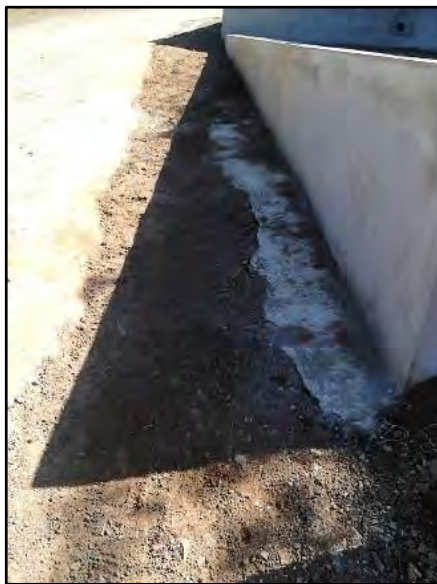
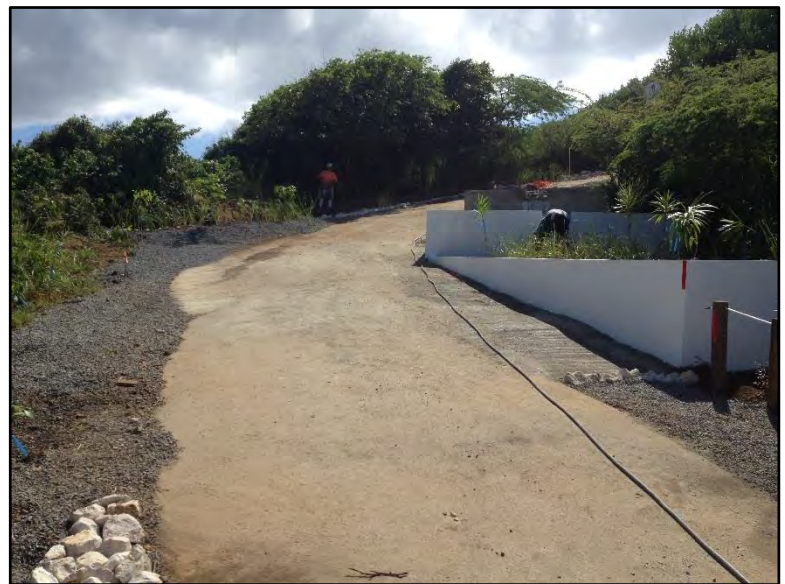
**Figure 16.** Pre and Post stabilization of paved road (Top) and repaired segment of the road (Bottom).

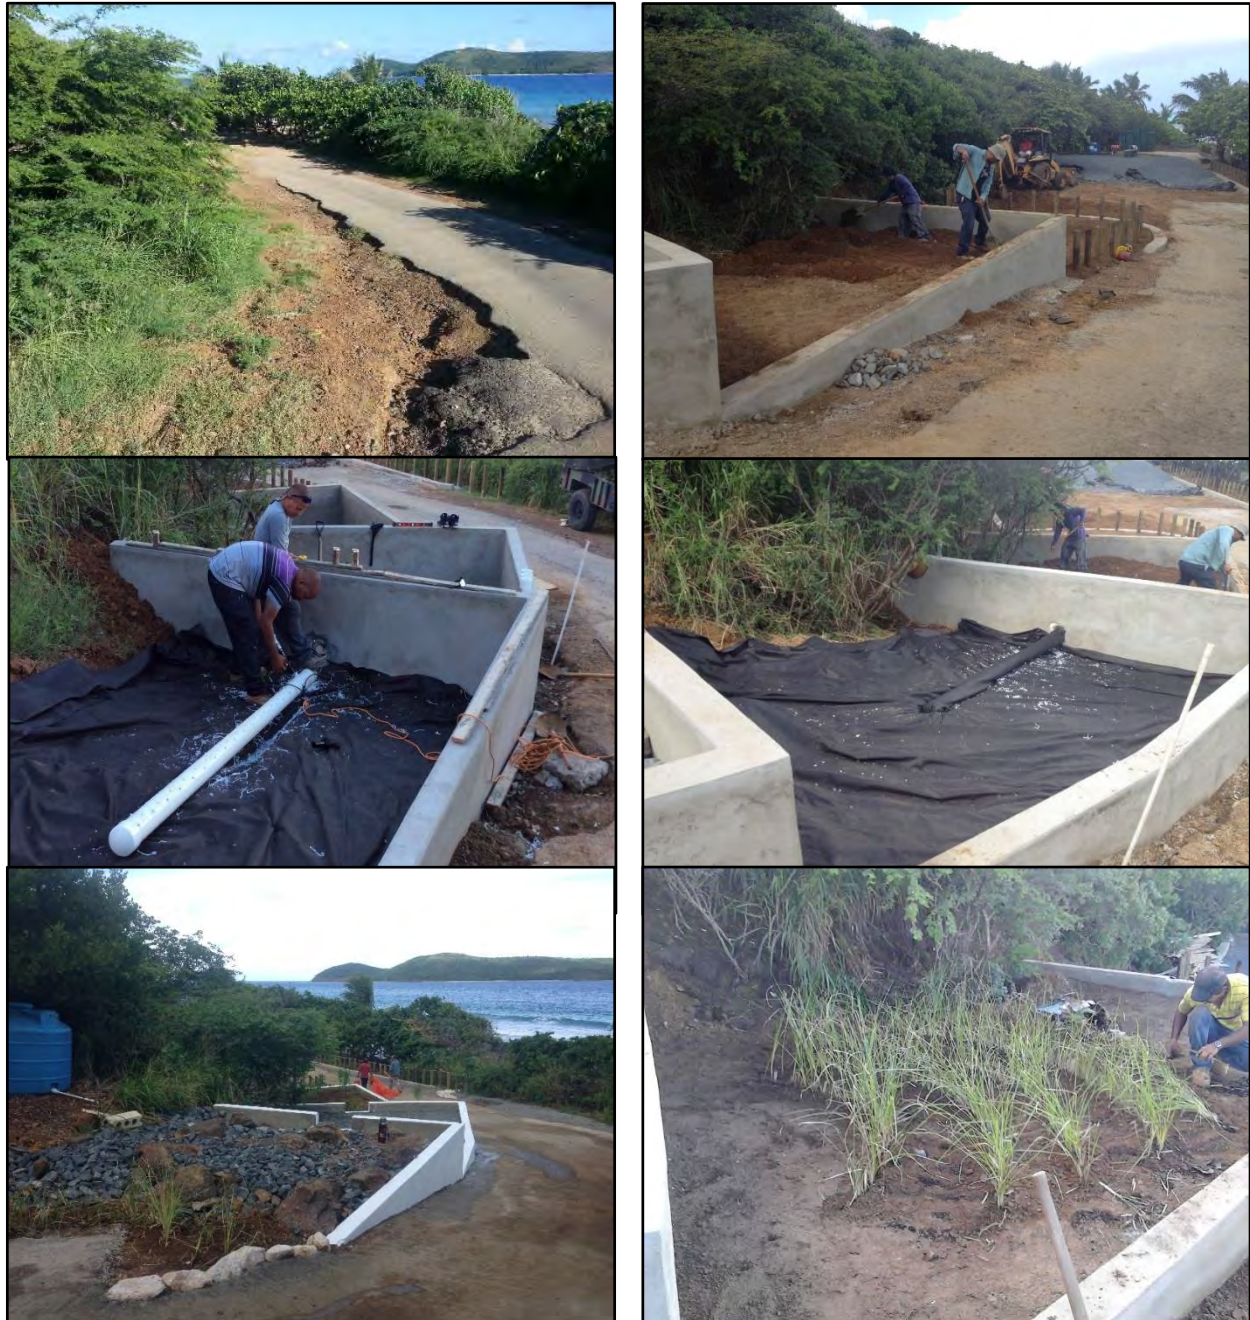
**Figure 18.** Construction of Filtration System.

A Rain Garden/Sediment Trap system was designed to help filter storm water that was discharged to Zoní Beach. The entire filtration process consists in three filtration chambers, a Rain garden and a permeable parking system (Figure 17). This practice was designed to treat residual runoff coming from the dirt and access roads that could not be addressed with stabilization practices discussed in the previous sections. Water is conveyed to the sediment trap by a concrete swale. In this design the three filtration chamber has a variable substrate particles in order to provide a reduction of sediment and hydraulic energy. This will allow water to pass throughout the chamber slowly while reducing sediment load. All of the chambers where design to hold a rain fall event of 10yr-24hr, which represent more than 90% of the rainfall that occurs in Culebra. The first filtration chamber was filled with 3" to 12" diameter rock, this will trap larger particle material transported by the storm water. The secondary chamber uses stones that vary between 1/8" to 1/2". The purpose is to trap sediment between the macro voids created in the substrate. While the third and final chamber, contains a blend of mostly sand with topsoil. Vetiver was planted in this chamber to further aid in the filtration process (Figure 18).

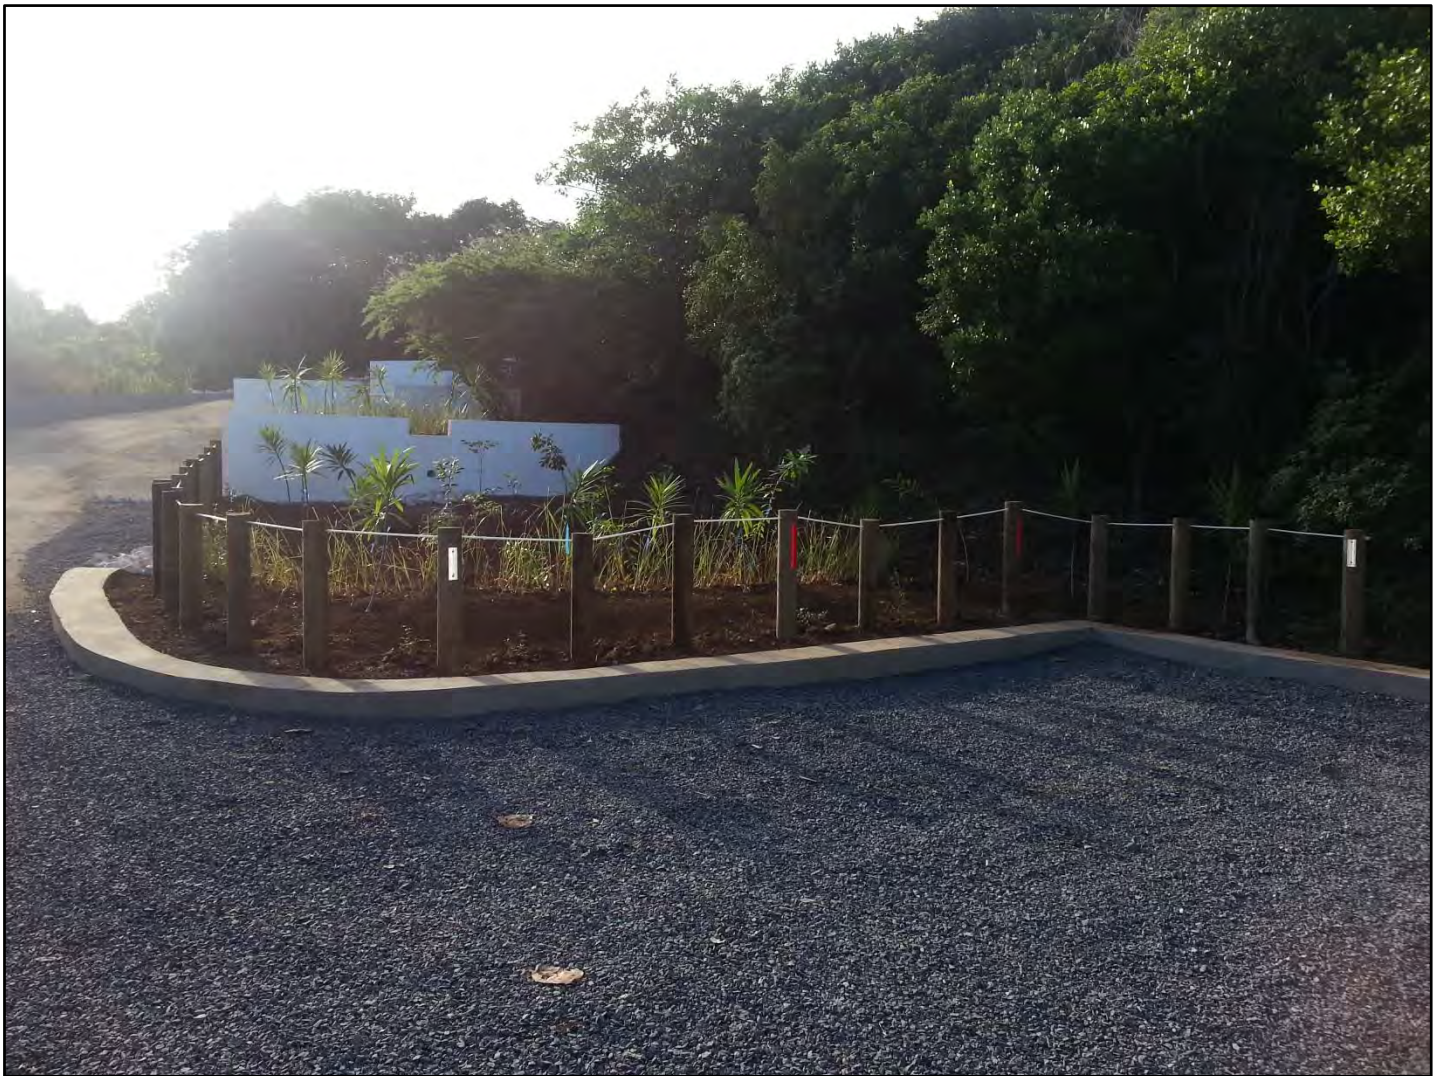
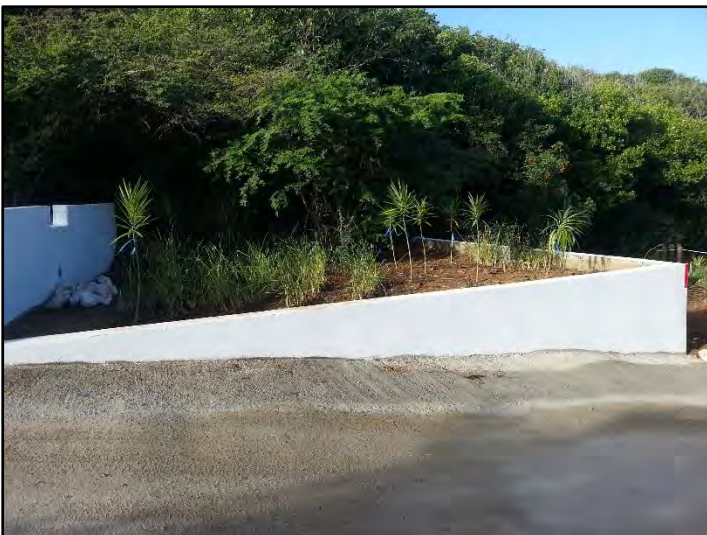
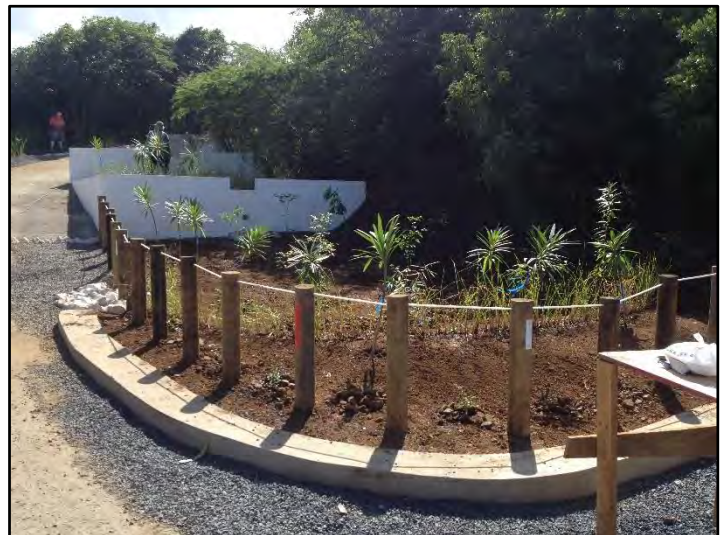
**Figure 19.** Rain Garden Component of the Filtration System.

At this point, sediment should be reduced significantly. A rain garden was placed at the end of the filtering process, this final step was designed to infiltrate small rainfall events and to discharge water slowly to the permeable parking area (Figure 19).

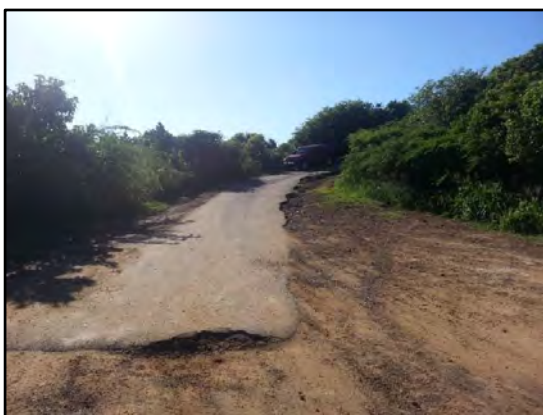
**Figure 20.** Parking area before stabilization.

The stabilized parking area consisted of approximately 500 m<sup>2</sup> (Figure 20). In this process, first, we delineated the parking area above the permanent vegetation zone of the beach. For this, treated wooden posts were buried about 18 inches deep and fixed with concrete at base leaving about 30 inches of pole to demarcate the area. Wooden posts were placed at a distance of three feet from each other and crossed with rope to prevent the passage of people and small vehicles such as golf carts that have become a major means of transportation in Culebra. Further, the parking area was developed using the best available technology to help in the sediment load reduction process (Figure 21). Parking was constructed with multiple layer base confined with a 1' concrete curb composed of; (1) geomembrane support (2) gabion with pebble stones as base, this allows support and drainage, (3) filter fabric, this eliminate the possibility of contamination of the base with sediment, and (4) a Geo-Cell with ¼" gravel infill, this will allow vehicle support and drainage of all stormwater (Figures 22, 23 and 24). Another important factor behind the parking design was the negative slope used to pond water at the center of the parking prior to its discharge

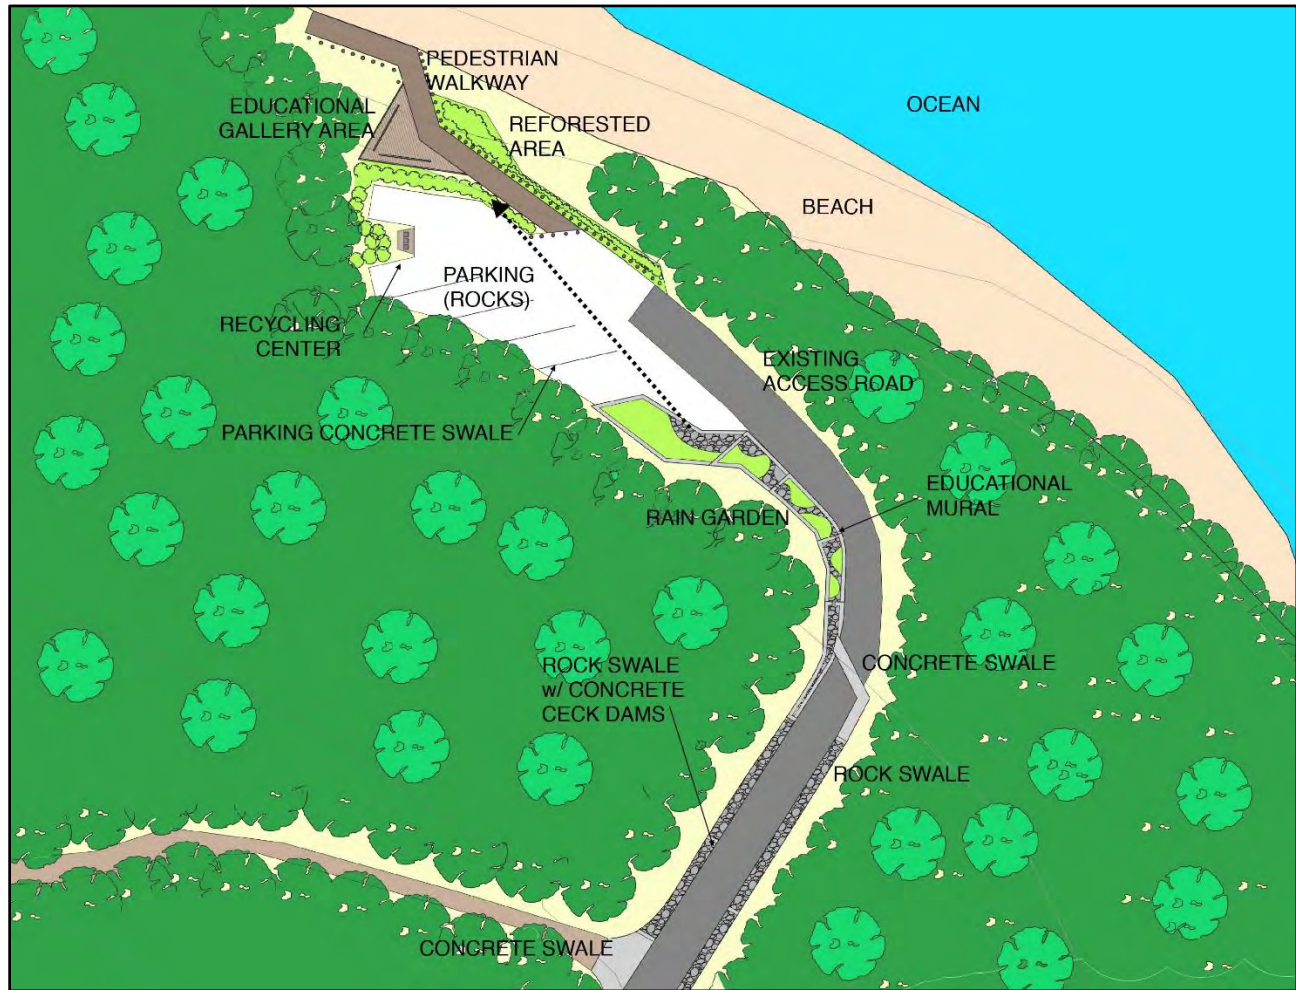
Figure 21. Schematic diagrams of practices Implemented (Top) and cross section diagram of parking filtration components.

throughout the beach channel. This will reduce significantly the discharge rate of storm water through the drainage channel which was re-planted with native vegetation to stabilize the erosion process affecting the beach.

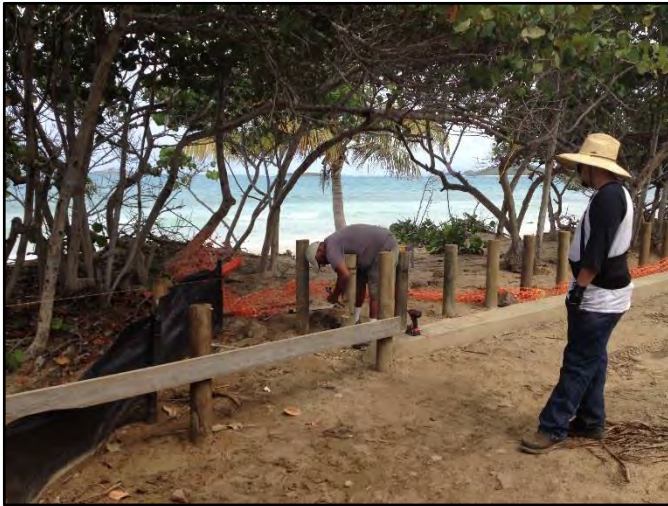
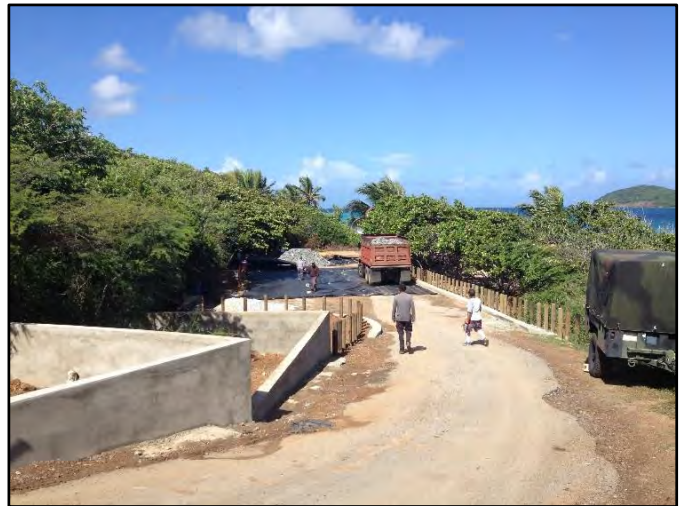
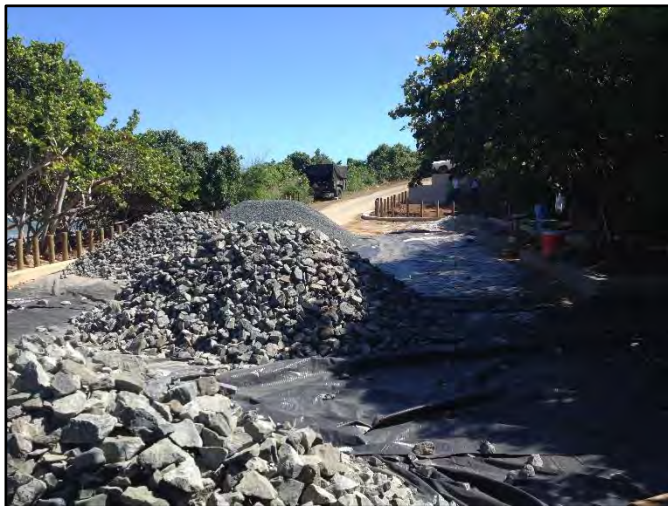
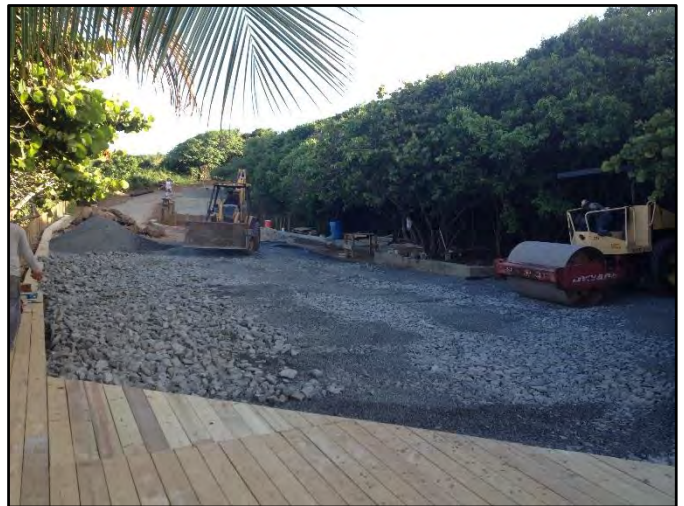
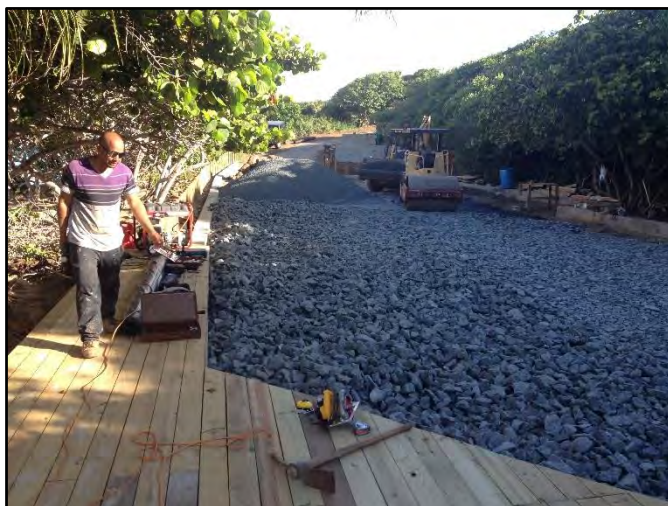
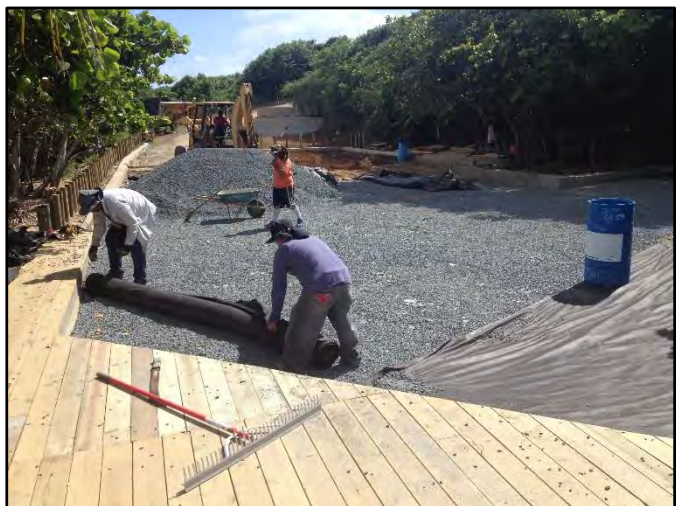
Figure 22. Parking filtration system construction.

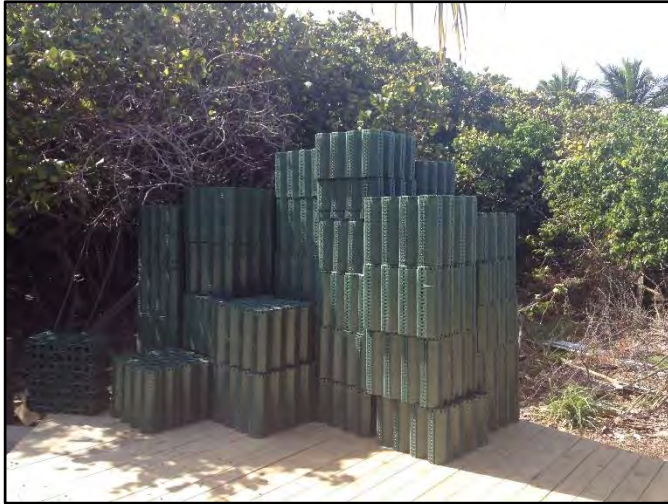
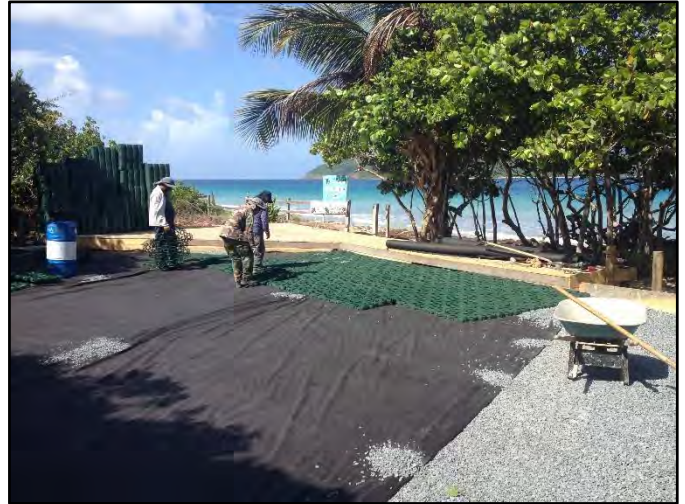
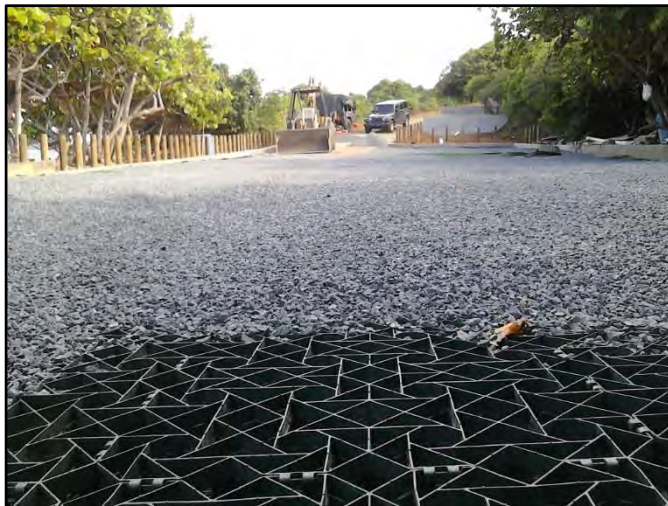
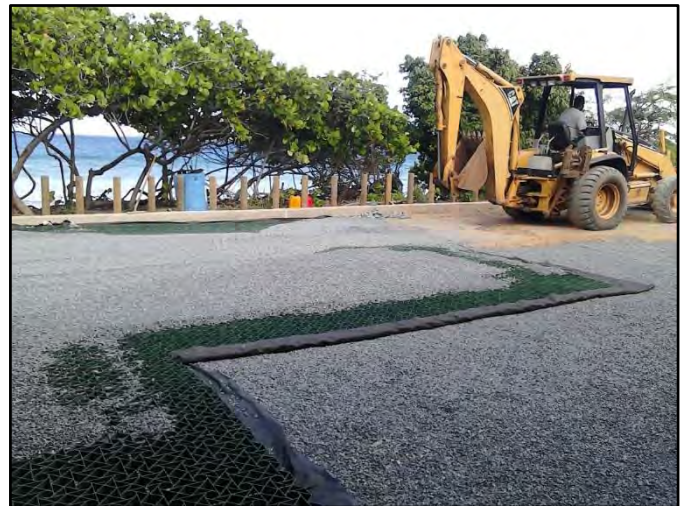
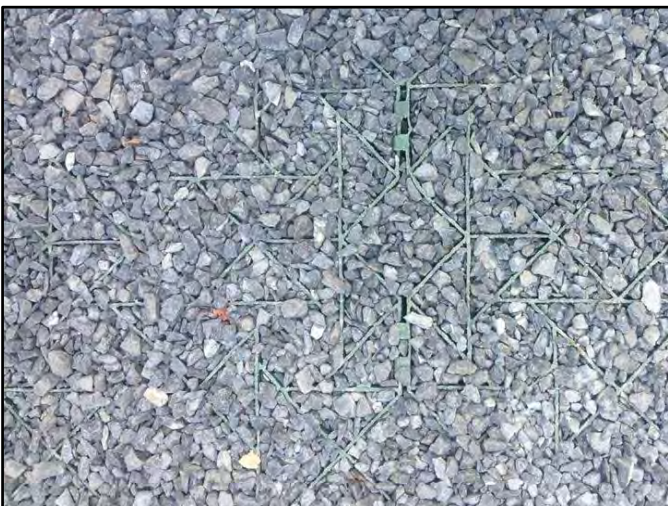
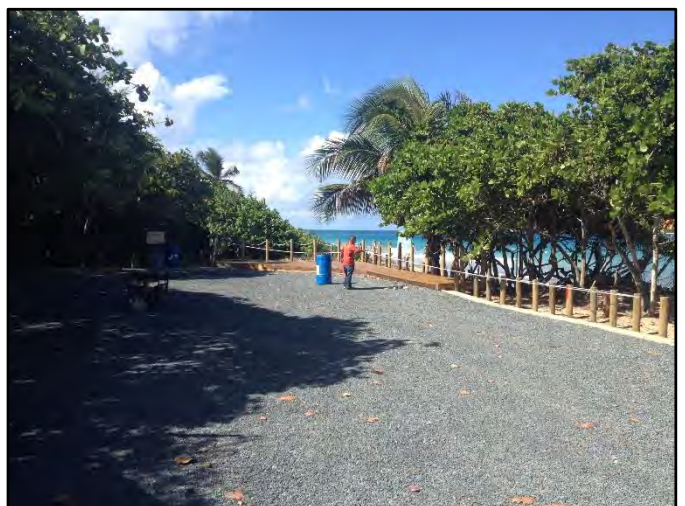
Figure 23. Parking filtration system construction.

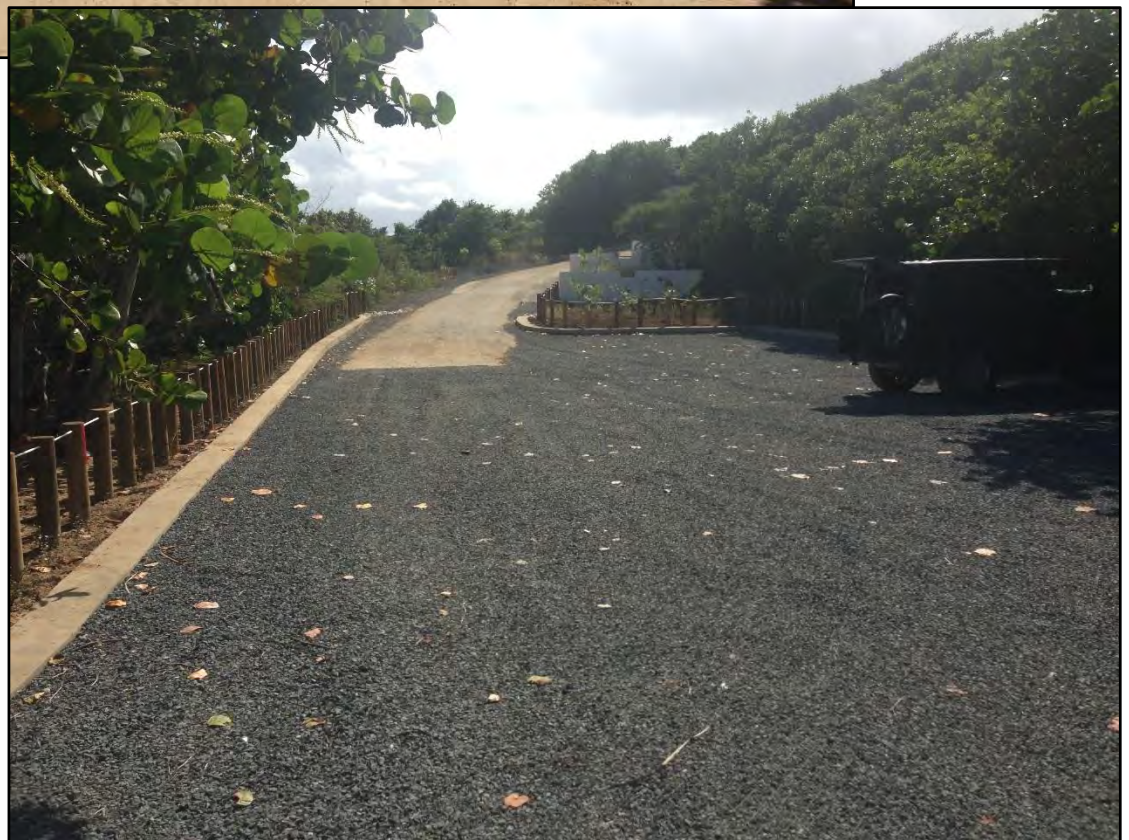
**Figure 24.** Parking area pre (top) and post (bottom) system construction.

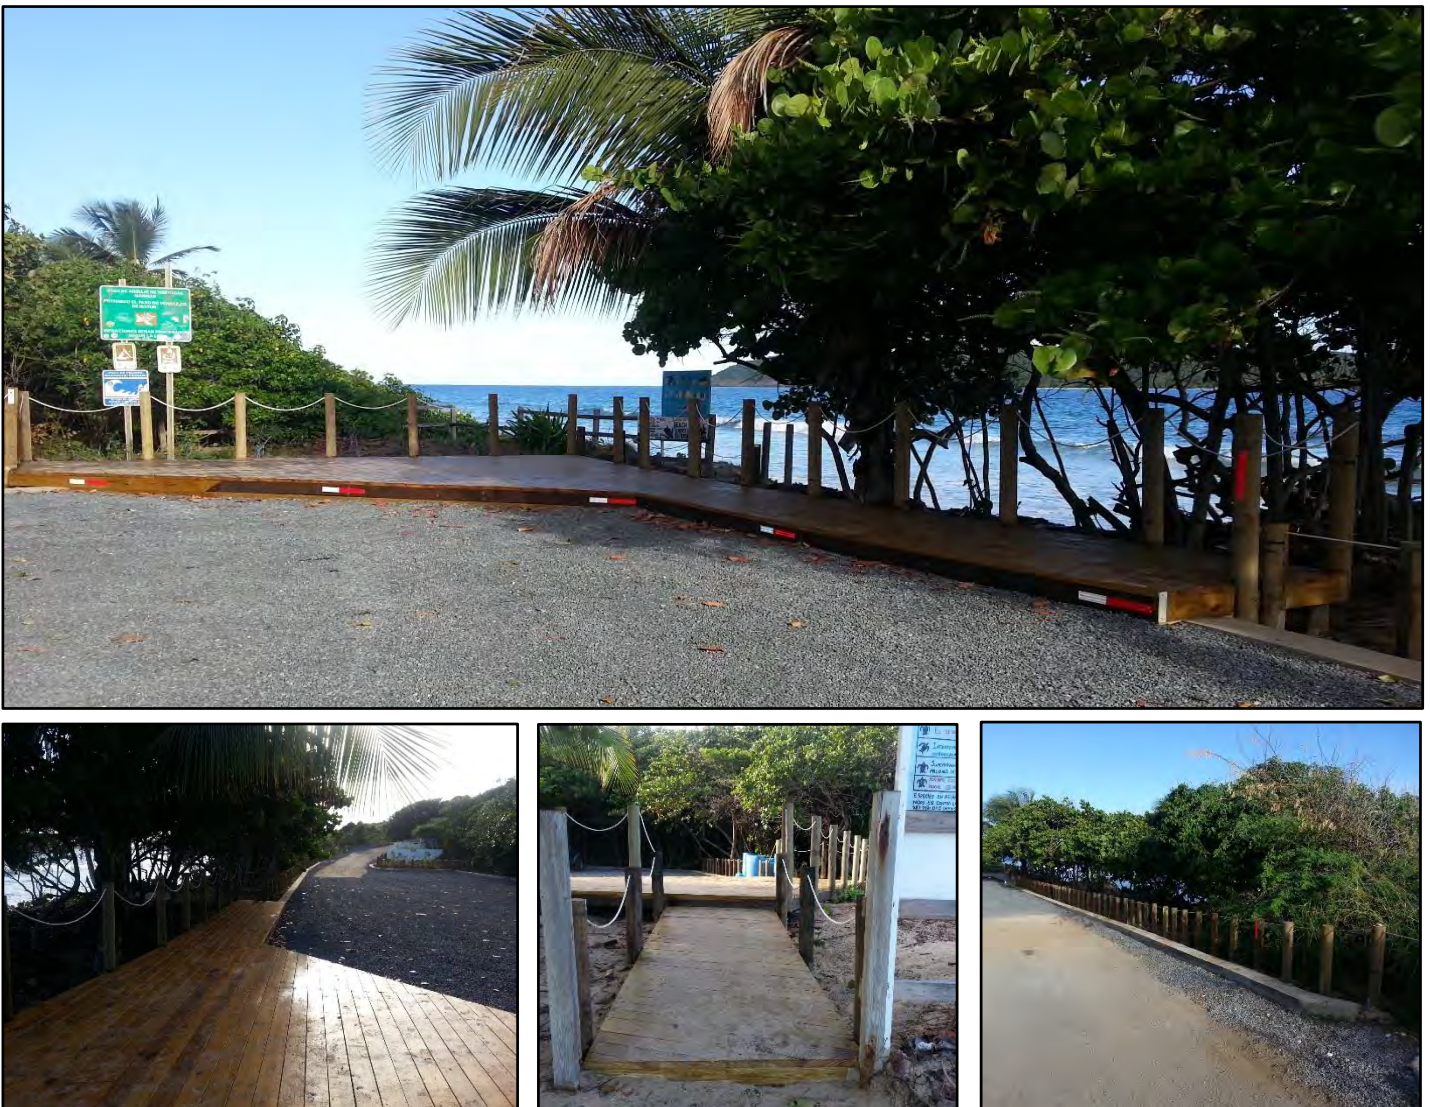
Figure 25. Elevated boardwalk and access delimitation.

A small elevated boardwalk was constructed for the public to access the beach without impacting vegetation and sand dunes (Figure 25). This area was closed to vehicular access by the installing wood poles and it has a defined pedestrian access area to the beach. This is accompanied by signage with educational information and rules to be followed by users.

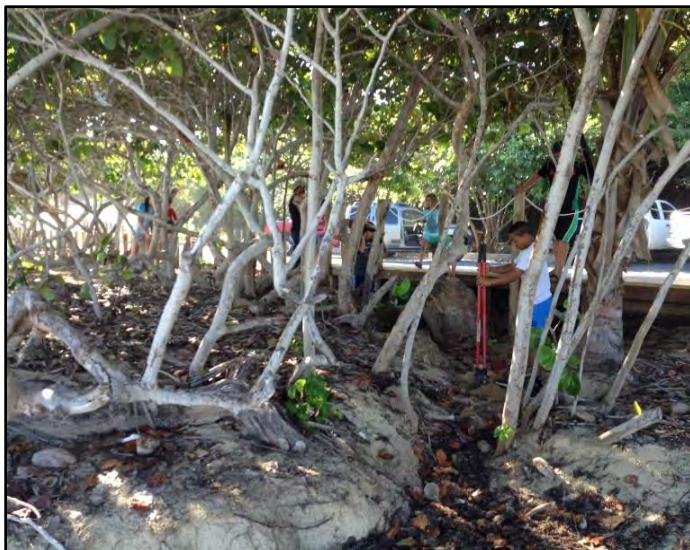
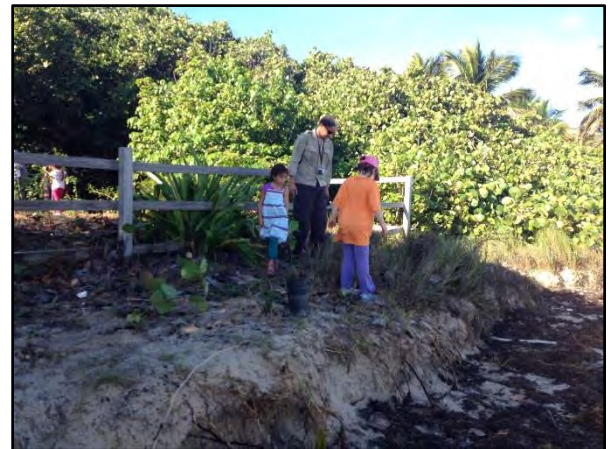
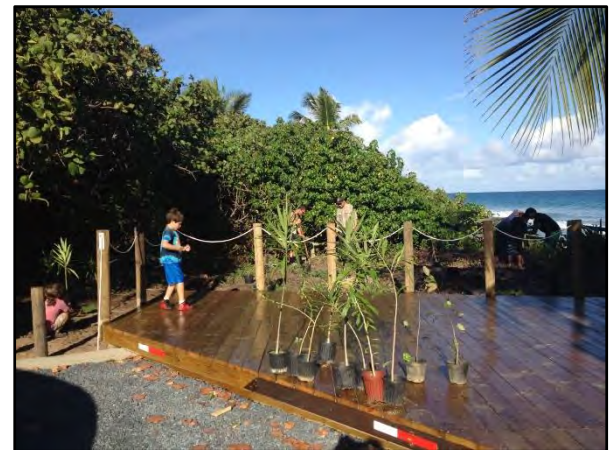
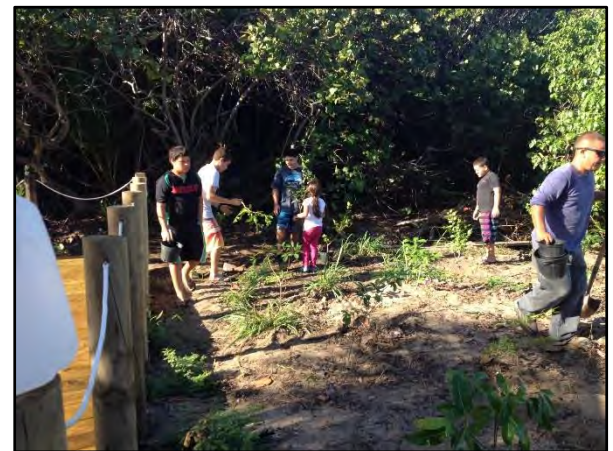
**Figure 26.** Process of reforestation of the vegetated zone of the beach with volunteers.

The coastal habitat at Zoní Beach has been seriously impacted by uncontrolled public access and erosion caused by concentrated flow. In order to restore the coastal vegetated berm and buffer, we re-planted the area with coastal native species. Plant material was provided by DNER and USFWS. A total of approximately 300 native trees were planted with active collaboration of local groups such as kids from Abbie's School and USFWS volunteers. Abbie's School was in charge of the watering and maintenance of the planted trees for 5 to 6 weeks. A cistern system was installed in the area and water was coordinated with the Municipality of Culebra (Figure 26).

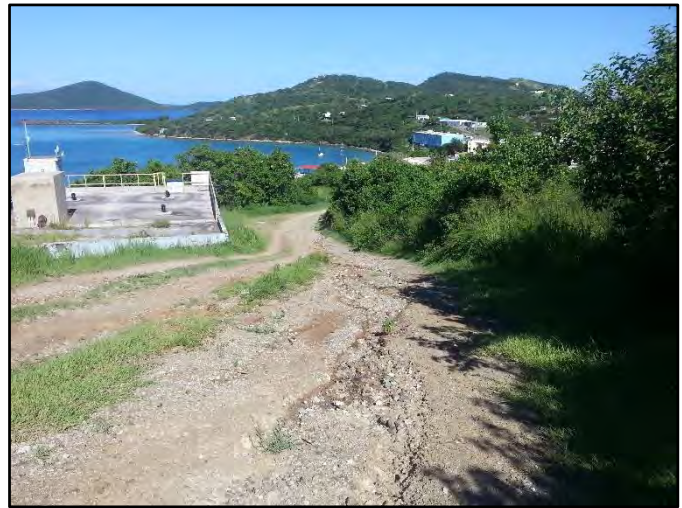
Figure 27. Dirt access road to the water tank prior to stabilization.

The Town site is located in a small subwatershed that drains to the Lobina Channel (Figure 1). Most of the access roads in the area are paved except for the road that goes to the main potable water reservoir at the top of the hill (Figure 27). This dirt road is very steep and serves as the major source of sediment-laden runoff to the Lobina Channel.

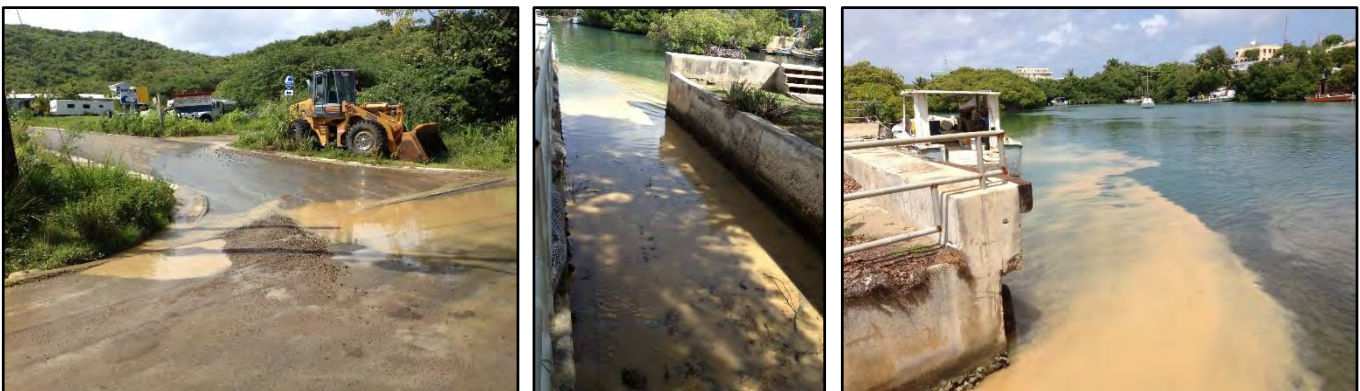
Figure 28. Water tank overflow prior to stabilization.

Another problem associated with this site is that when the water reservoir tank overflows it drains from top of the hill through a steep slope in a dirt channel it has created over time piping and erosion of fine sediments and carrying them to the near shore environment (Figure 28).

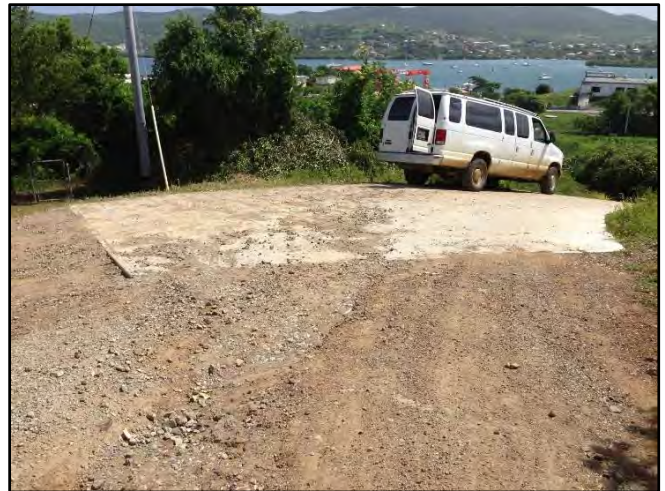
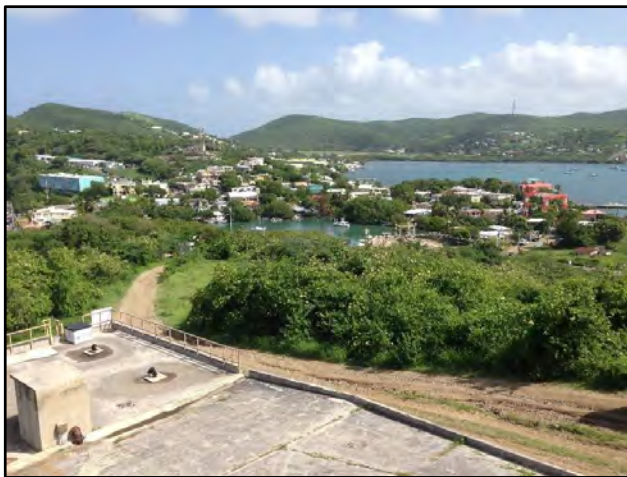
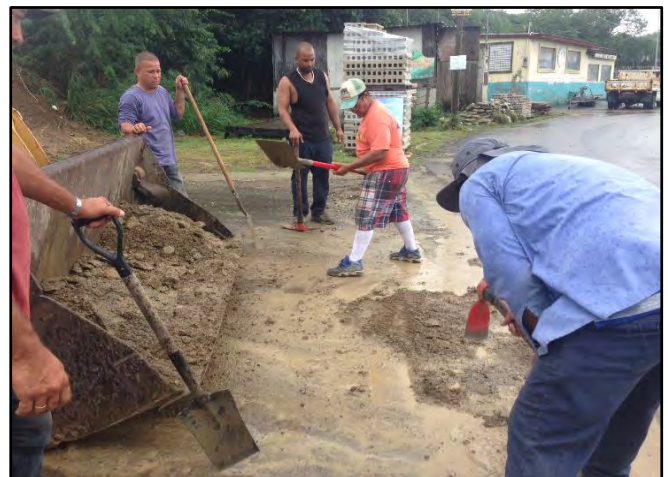
**Figure 30.** Town site prior to implementation.

In order to be able to stabilize this site, a series of components were constructed to increase the effectiveness of the conservation practices implemented and help reduce sediment transport to the Lobina channel and the nearshore reefs (Figure 29). A total of three rain gardens/sediment traps were constructed. The project resulted in over 150 native trees and 1000 Vetiver plants being planted to help stabilize conveyances and re-establish native vegetation. Cross swales and a series of check dams with riprap and Vetiver were established to redirect runoff to the rain gardens and reduce the energy of the water. An infiltration gallery was created to address runoff from an uncontrolled drainage area from the overflow of the water reservoir tank (Figures 30 and 31).
