**Reduction and Control of Sediment-Laden Runoff to Coastal Waters through the Implementation of Best Management Practices (BMP's), Coastal Habitat Rehabilitation and Delimitation of Public Access at Culebra, Puerto Rico**

**FINAL REPORT**

August, 2015

*Projects toward the implementation of the Culebra Community Watershed Action Plan for Coral Reefs and Water Quality*

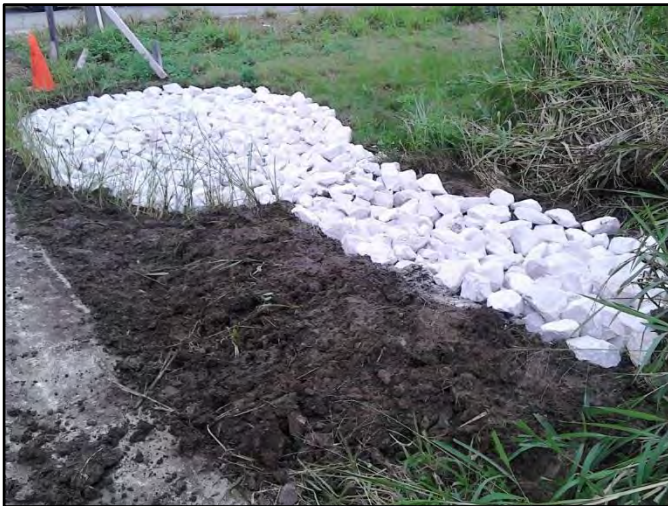
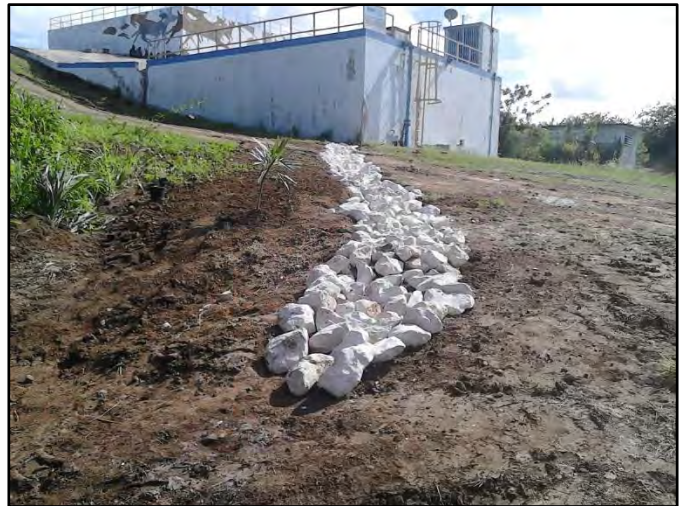
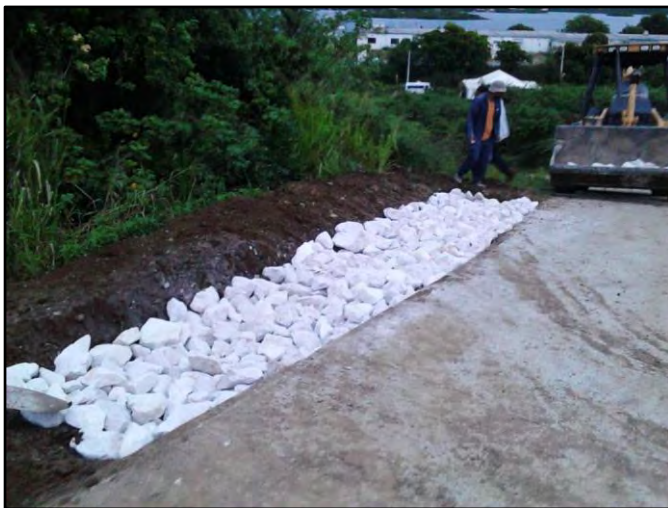
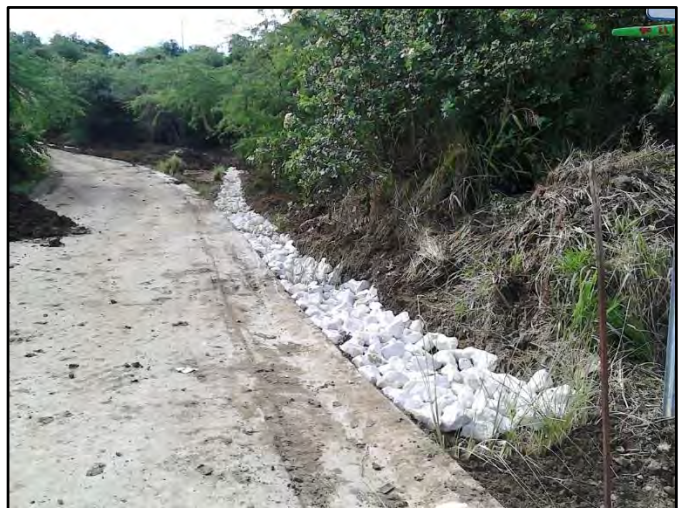
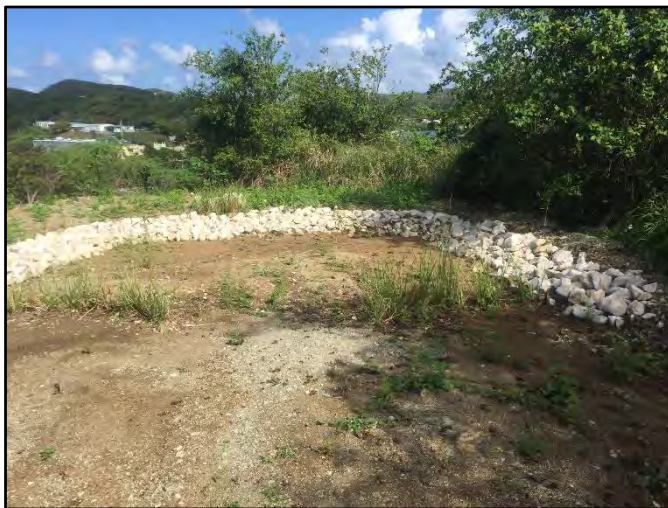
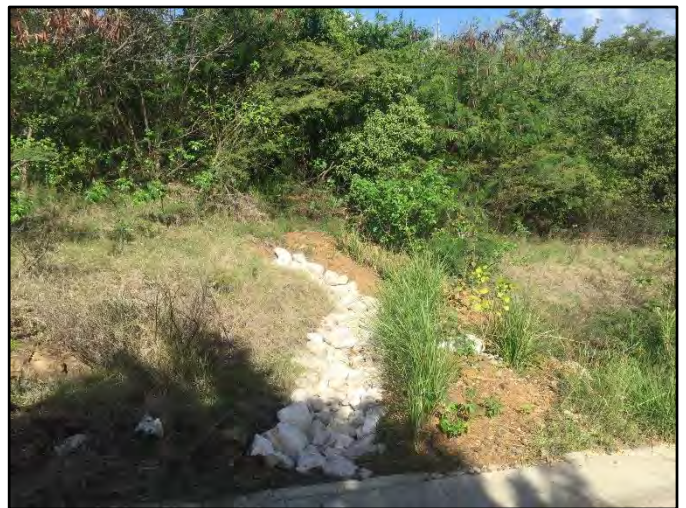
Figure 31. Town site after implementation.

In order to be able to stabilize this site, a series of components were constructed to increase the effectiveness of the conservation practices implemented and help reduce sediment transport to the Lobina channel and the nearshore reefs (Figure 29). A total of three rain gardens/sediment traps were constructed. The project resulted in over 150 native trees and 1000 Vetiver plants being planted to help stabilize conveyances and re-establish native vegetation. Cross swales and a series of check dams with riprap and Vetiver were established to redirect runoff to the rain gardens and reduce the energy of the water. An infiltration gallery was created to address runoff from an uncontrolled drainage area from the overflow of the water reservoir tank (Figures 30 and 31).
