# **Preliminary Survey of Point Sources of Pollution in La Parguera, Lajas Puerto Rico**

**February 2012**

## Summary:

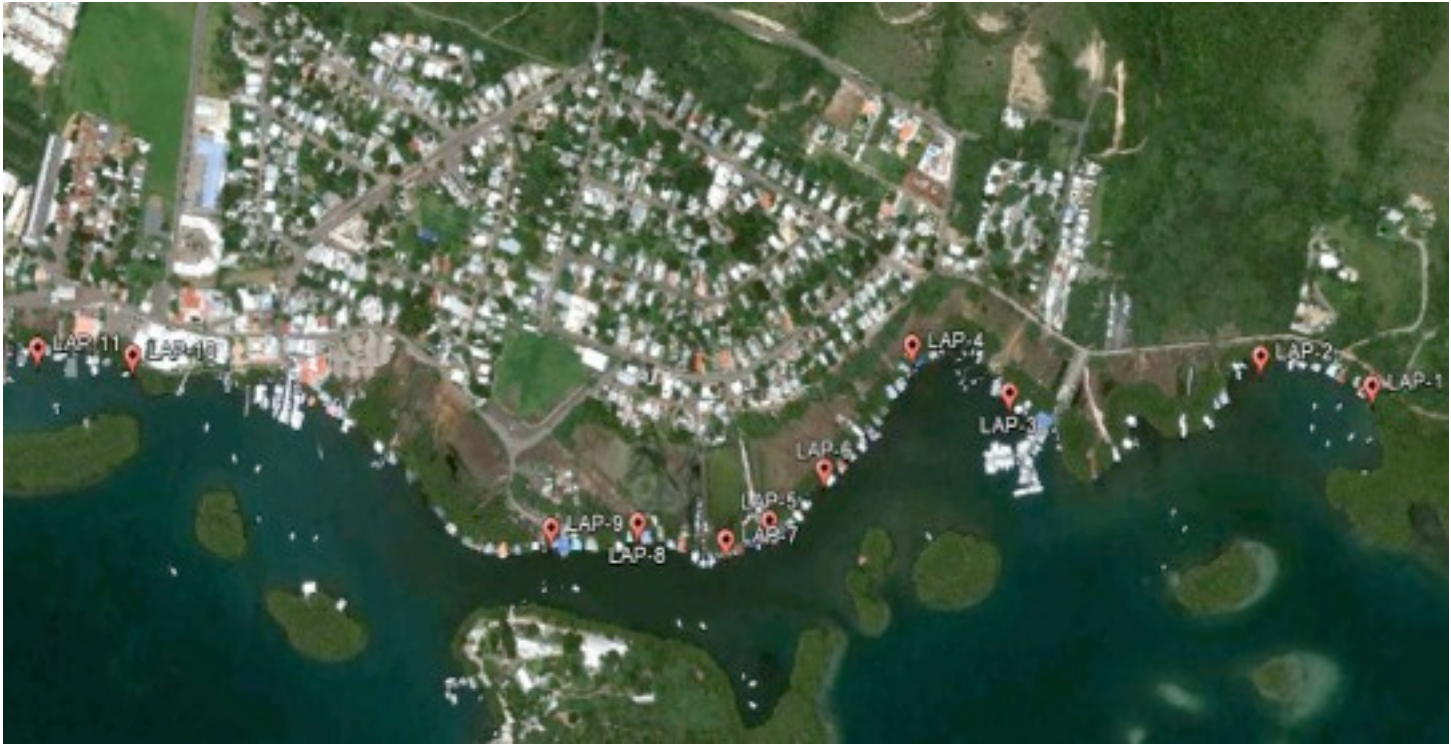
FIGURE 2: Sampling sites for ammonia

<b>Site</b>	<b>Ammonia ( mg/L)</b>	<b>Lat</b>	<b>Long</b>
LAP-1	0.06	17.973001°	-67.034619°
LAP-2	0	17.973500°	-67.035921°
LAP-3	0	17.972876°	-67.038918°
LAP-4	0.12	17.973316°	-67.040470°
LAP-5	0.35	17.971528°	-67.042309°
LAP-6	0	17.972092°	-67.041619°
LAP-7	0.15	17.971382°	-67.042886°
LAP-8	0	17.971550°	-67.043982°
LAP-9	0.11	17.971597°	-67.045152°
LAP-10	0.40	17.973448°	-67.050515°
LAP-11	**	17.973641°	-67.051668°

\*\*Could not get reading; water may have been too turbid and polluted

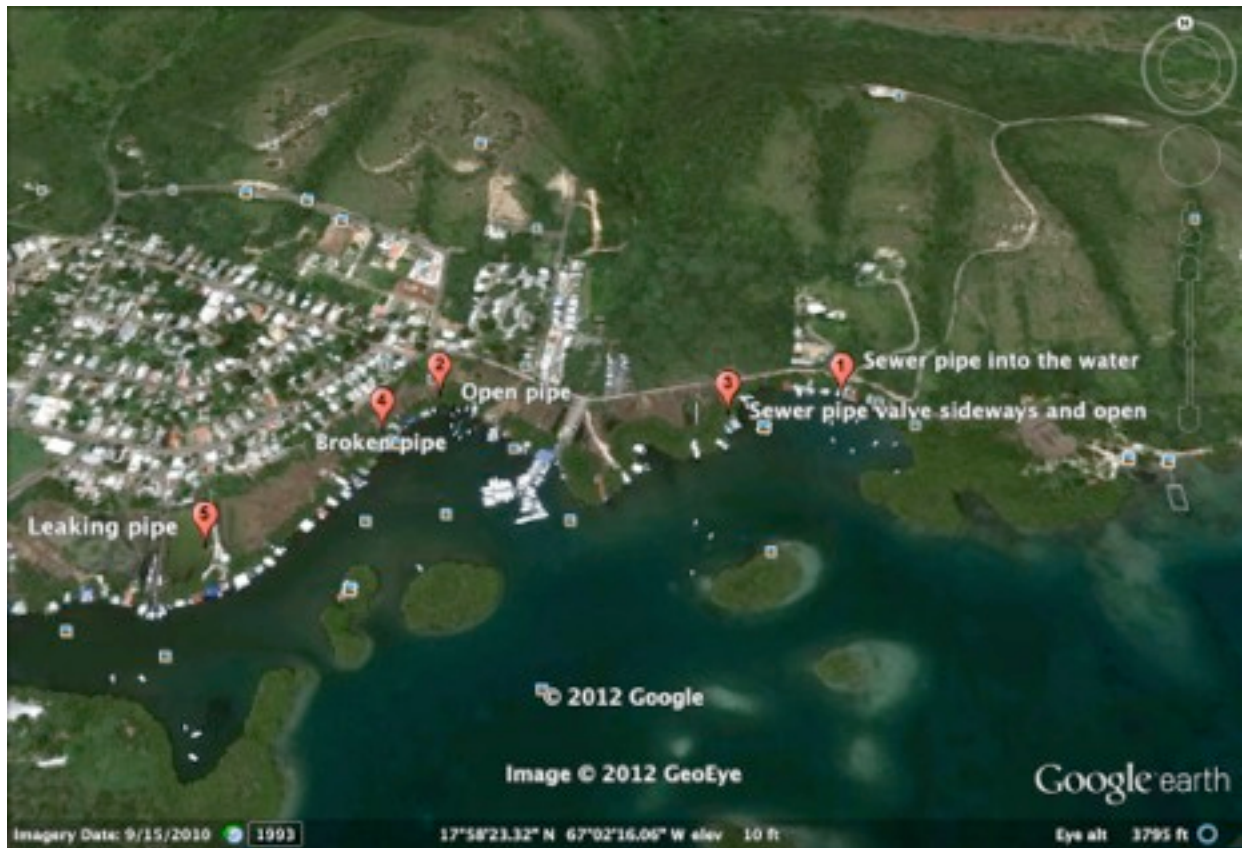
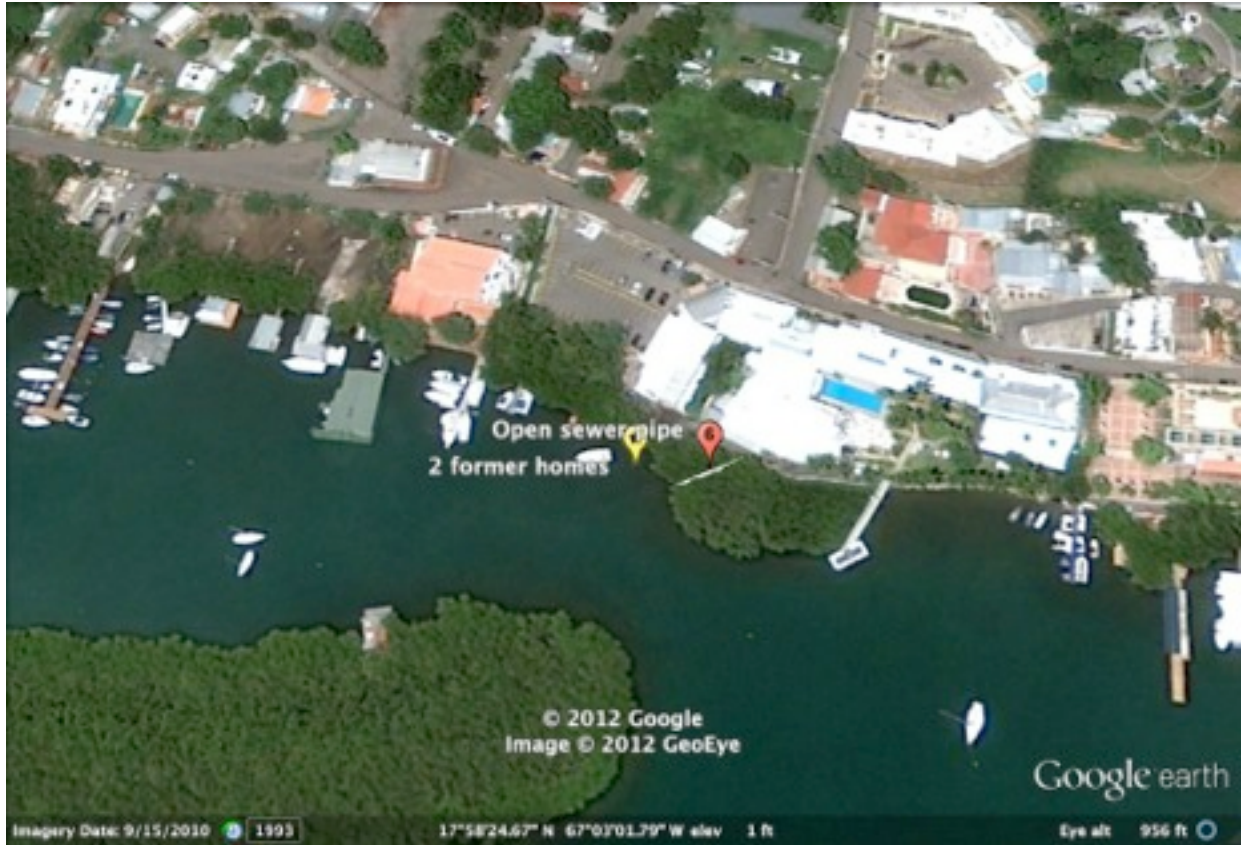
## Appendix I Locations of Potential Contamination

<b>Problem</b>	<b>Existing Home</b>	<b>Lat</b>	<b>Long</b>	<b>Notes</b>
1	Y	17.973297°	-67.035102°	Sewer pipe extends into the water (Figure 3)
2	N	17.973784°	-67.040025°	Open sewer pipe (Figure 6)
3	Y	17.973192°	-67.036534°	Open sewer pipe valve sideways and open (Figure 8)
4	Y	17.973340°	-67.040710°	Broken pipe
5	Y	17.972058°	-67.042669°	Leaking sewer pipe (Figure 12)
6	N	17.973412°	-67.050248°	Open sewer pipe -- no longer connected to house (Figure 15)

1. Re-line or re-engineer the main trunk of the sewer system in La Parguera, sealing all connections that are no longer needed and removing defunct pipes; consider a vacuum or other system that will withstand future sea level rise which will further exacerbate inflow and infiltration (I and I) conditions leading to additional coastal pollution.

2. Implement mandatory grinder pumps or composting toilets and 3 year inspections of the sewage lines at the stilt homes. As these homes are currently located in an extremely sensitive ecosystem area and in many instances using a primitive sewage disposal system that defies logic where the pipes are expected to defy the laws of gravity and pressure. This could be implemented with coastal health of both human and marine organisms in mind. We estimate these costs are approximately \$500 - \$1500 per household for composting toilets, and \$1500 - \$5000 for effective pumps and replacement of failing pipe systems where needed. Note a number of homes have already put into place effective pumps and well sealed sewer lines.
